CHAPTER 2

PARKS & FACILITIES ASSESSMENTS

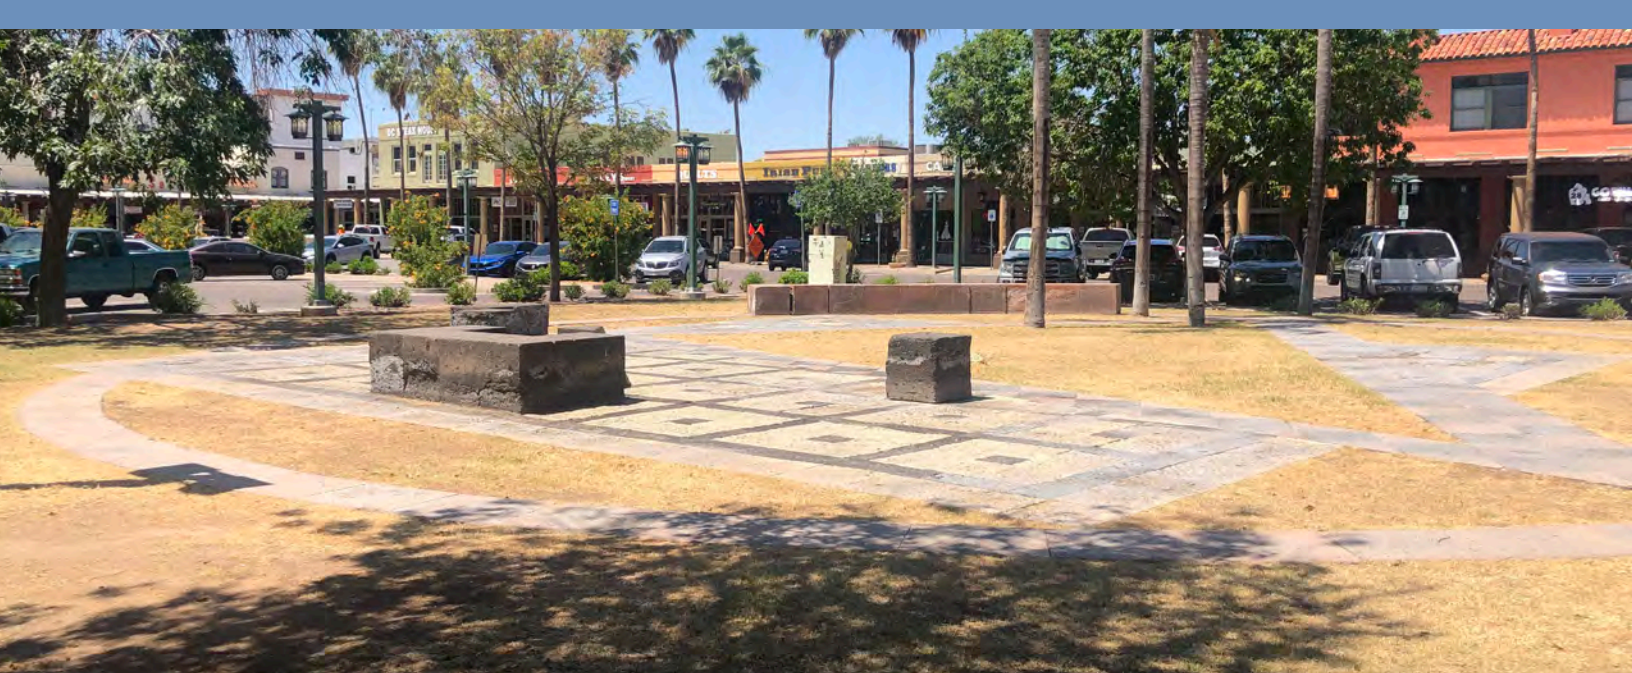
Turf Areas

The turf areas have patches of yellow with some green areas. Ground is pretty compacted throughout. Large shade tree canopies have contributed to non growth turf areas. The condition is due to lack of irrigation maintenance not activity. An aeration and soil agronomy test to evaluate soil condition and recommendations for amendments is suggested

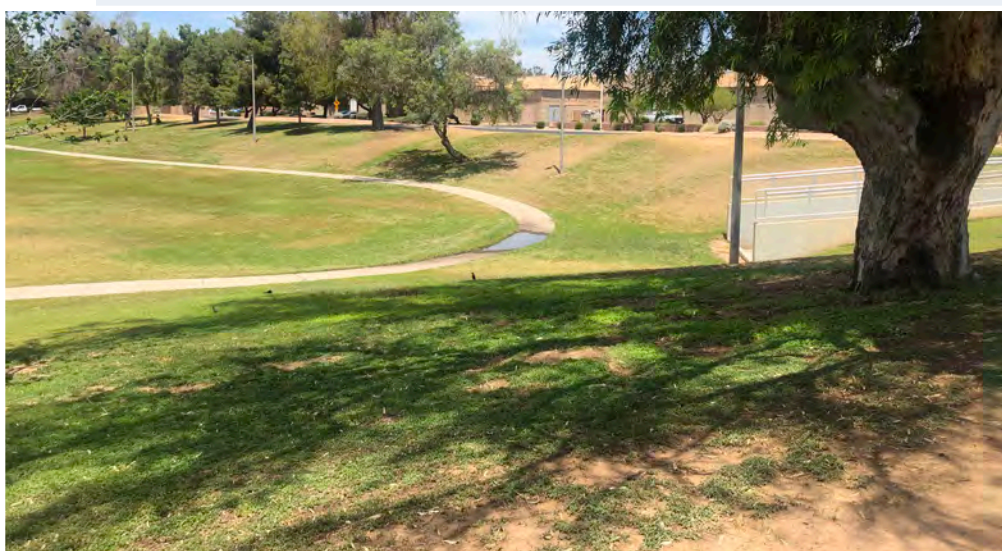
Sidewalk

The concrete sidewalk is in average condition. There are a number of panels with minor cracking, which should be monitored but there does not appear to be any vertical separation.

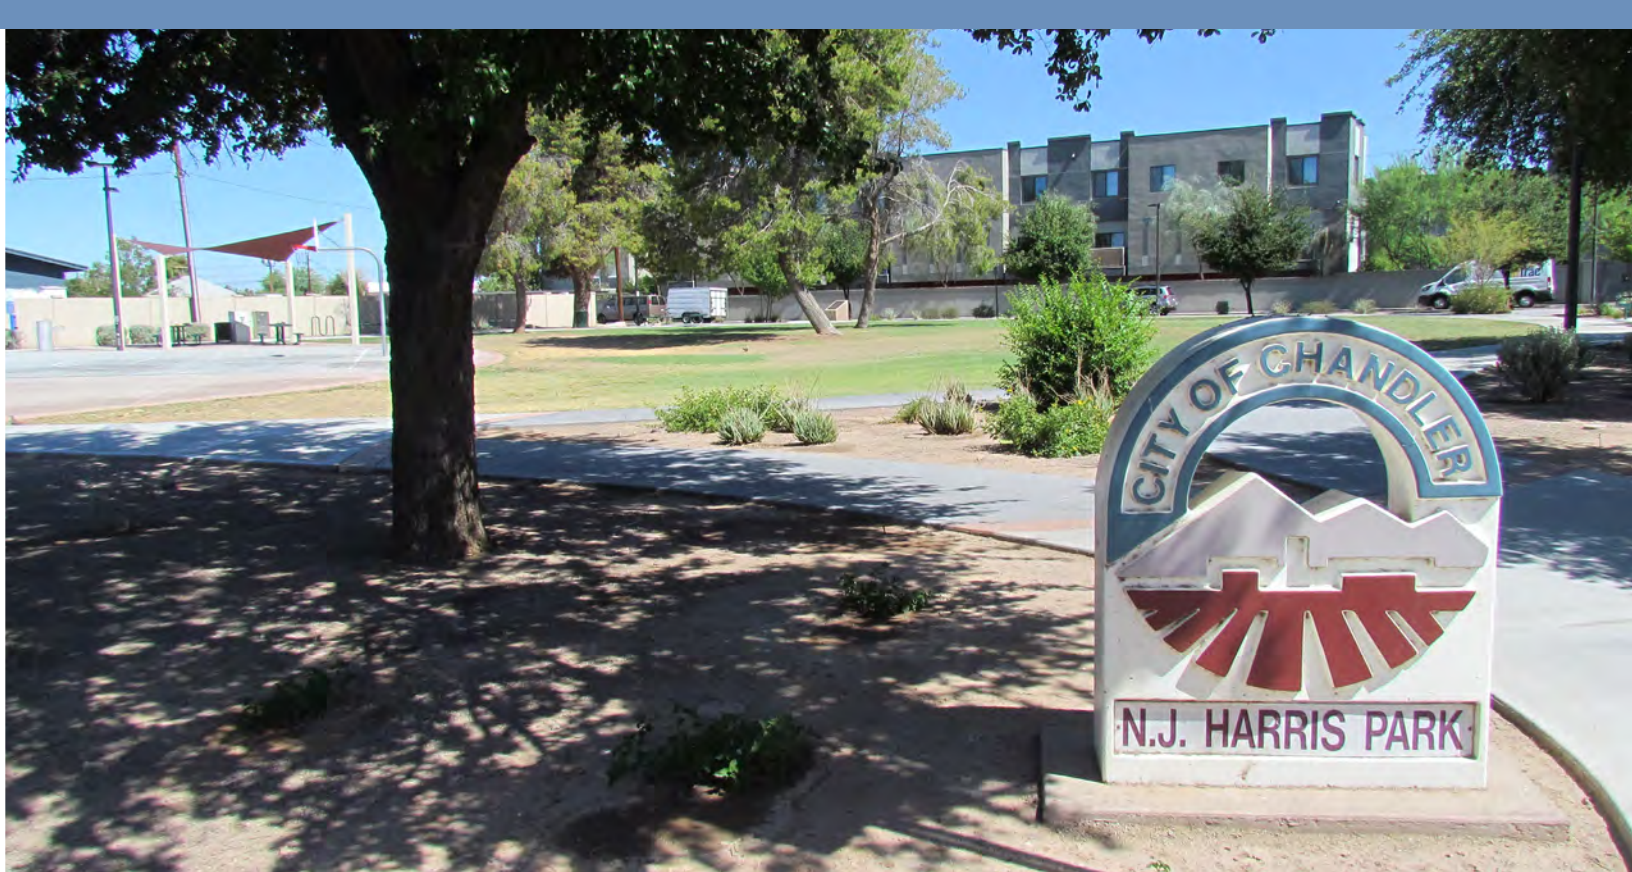
Turf Area

The north turf area is in poor condition with a lot of worn areas and very compacted throughout. An aeration and soil agronomy test to evaluate soil condition is recommended.
