RE:           **Job# 01-18-0142**  
                  Limited Asbestos and Lead Paint Survey  
                  **Chandler Heights Rd Improvements**  
                  **Chandler Heights Road (McQueen Road to Gilbert Road)**  
                  **ADOT TRACS NO. 0000 MA CHN T0099 01C**  
                  Chandler, Maricopa County, Arizona

**Limited Asbestos and Lead Paint Survey  
Chandler Heights Road Improvement Project  
July 30, 2018**

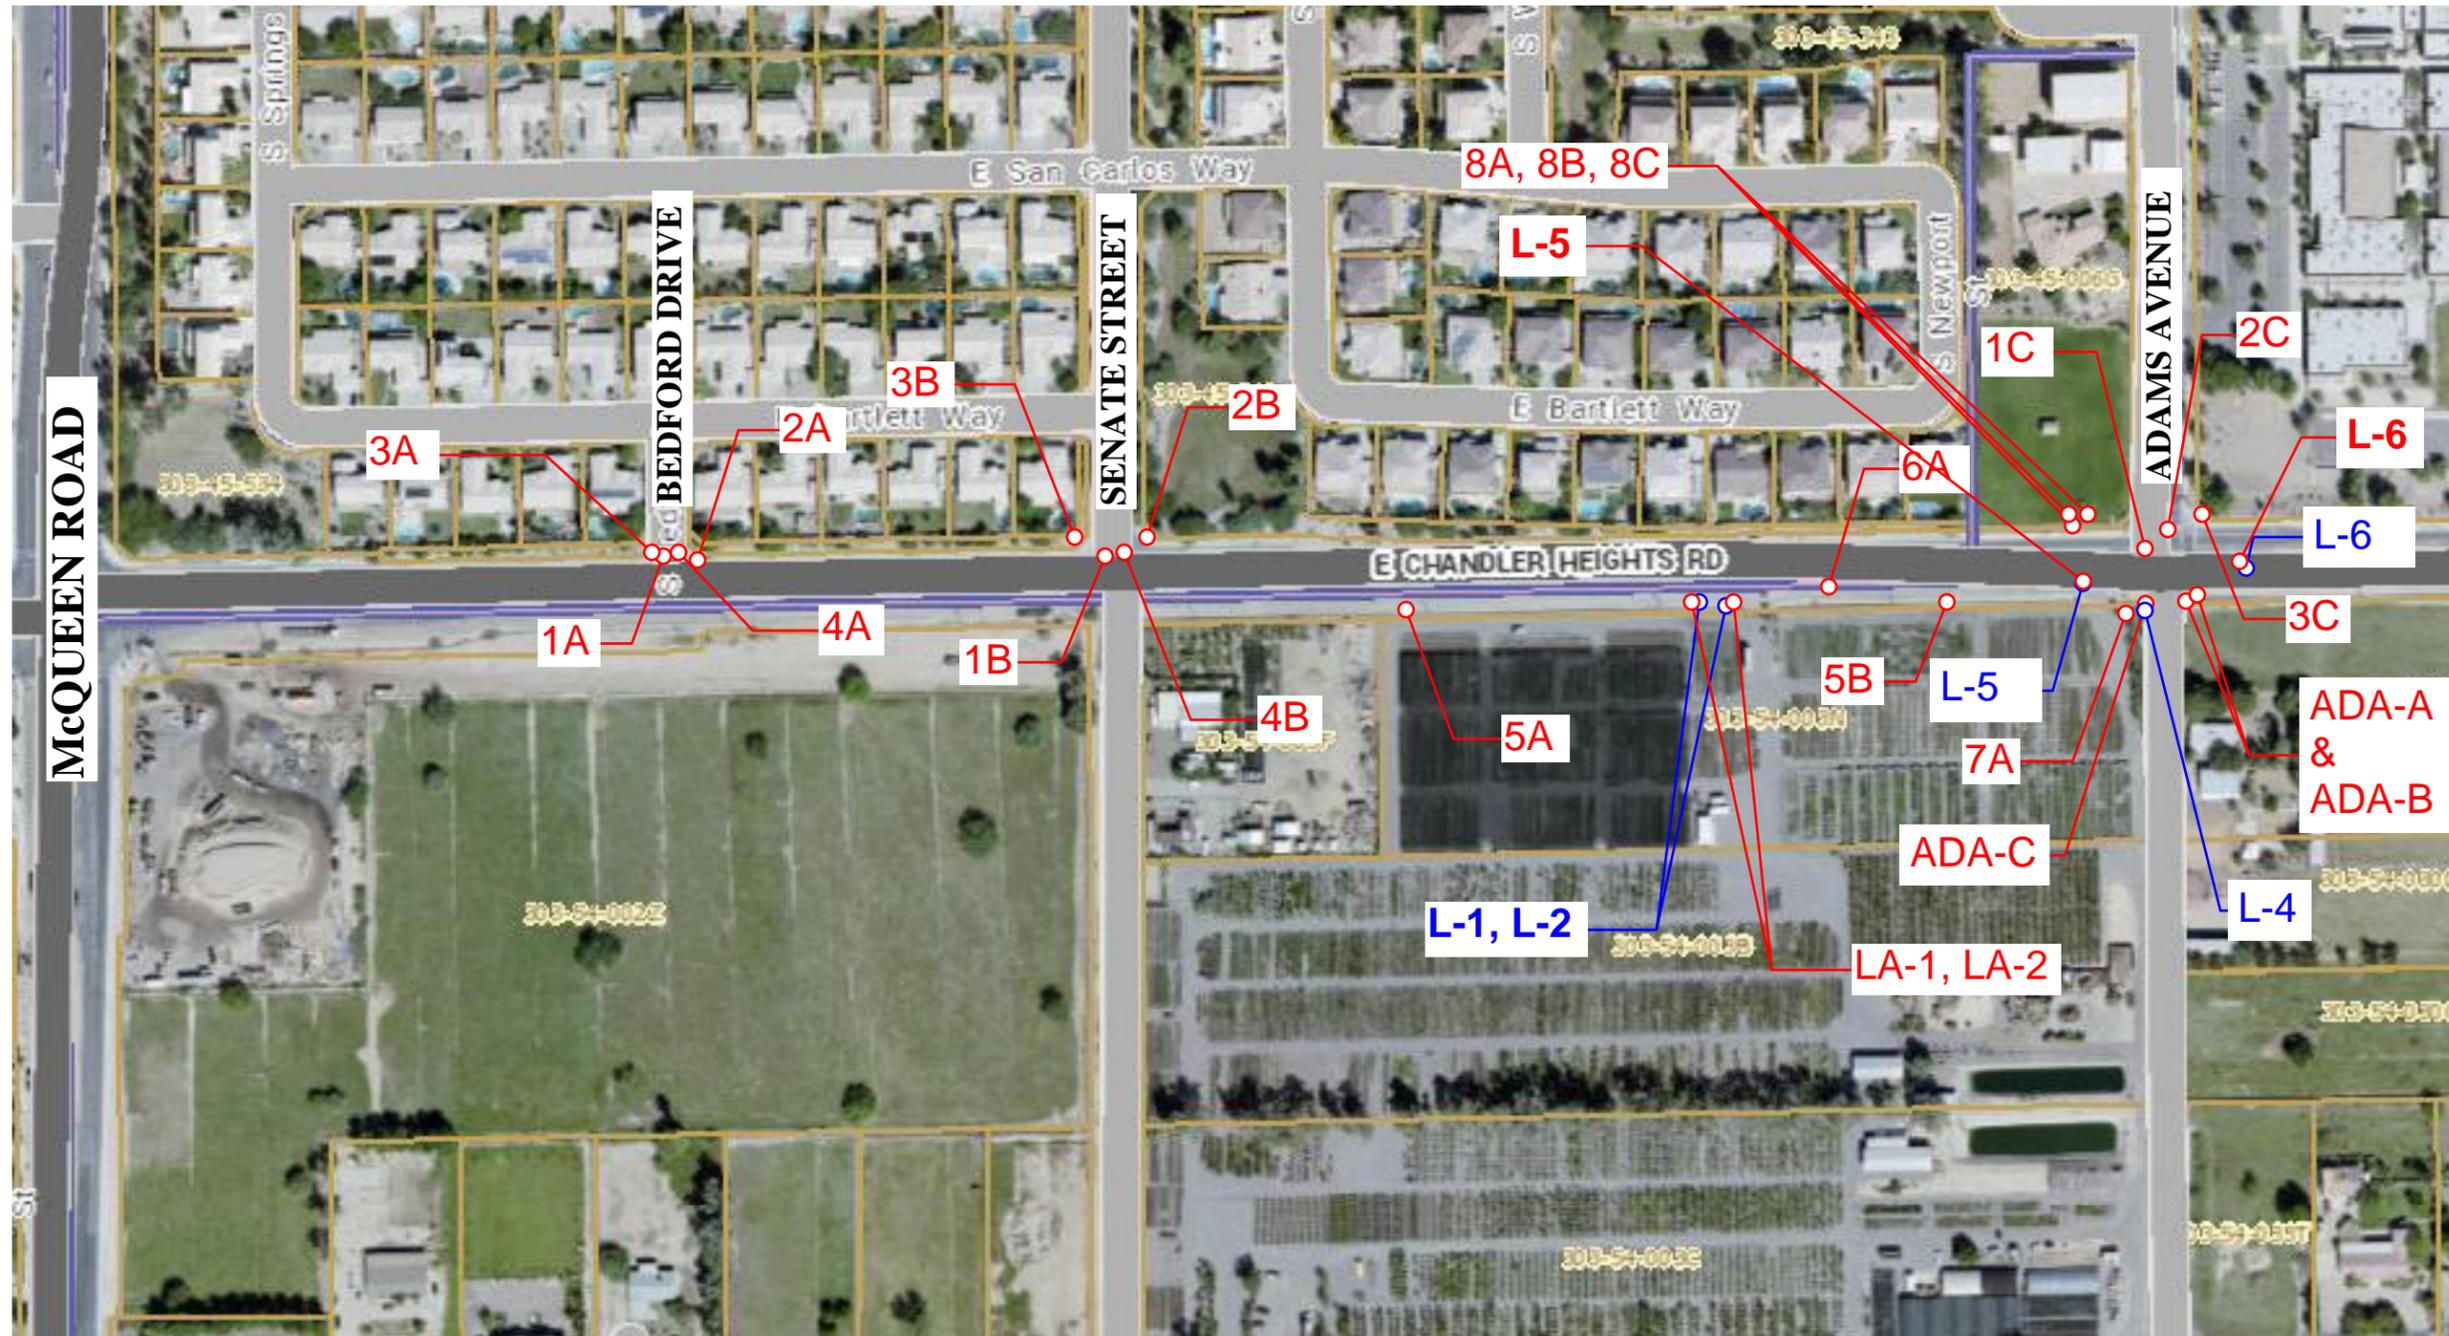
1

# Chandler Heights Road Improvements - McQueen to Adams Avenue

**NO  
ASBESTOS  
DETECTED**

**NO LEAD  
PAINT  
DETECTED**

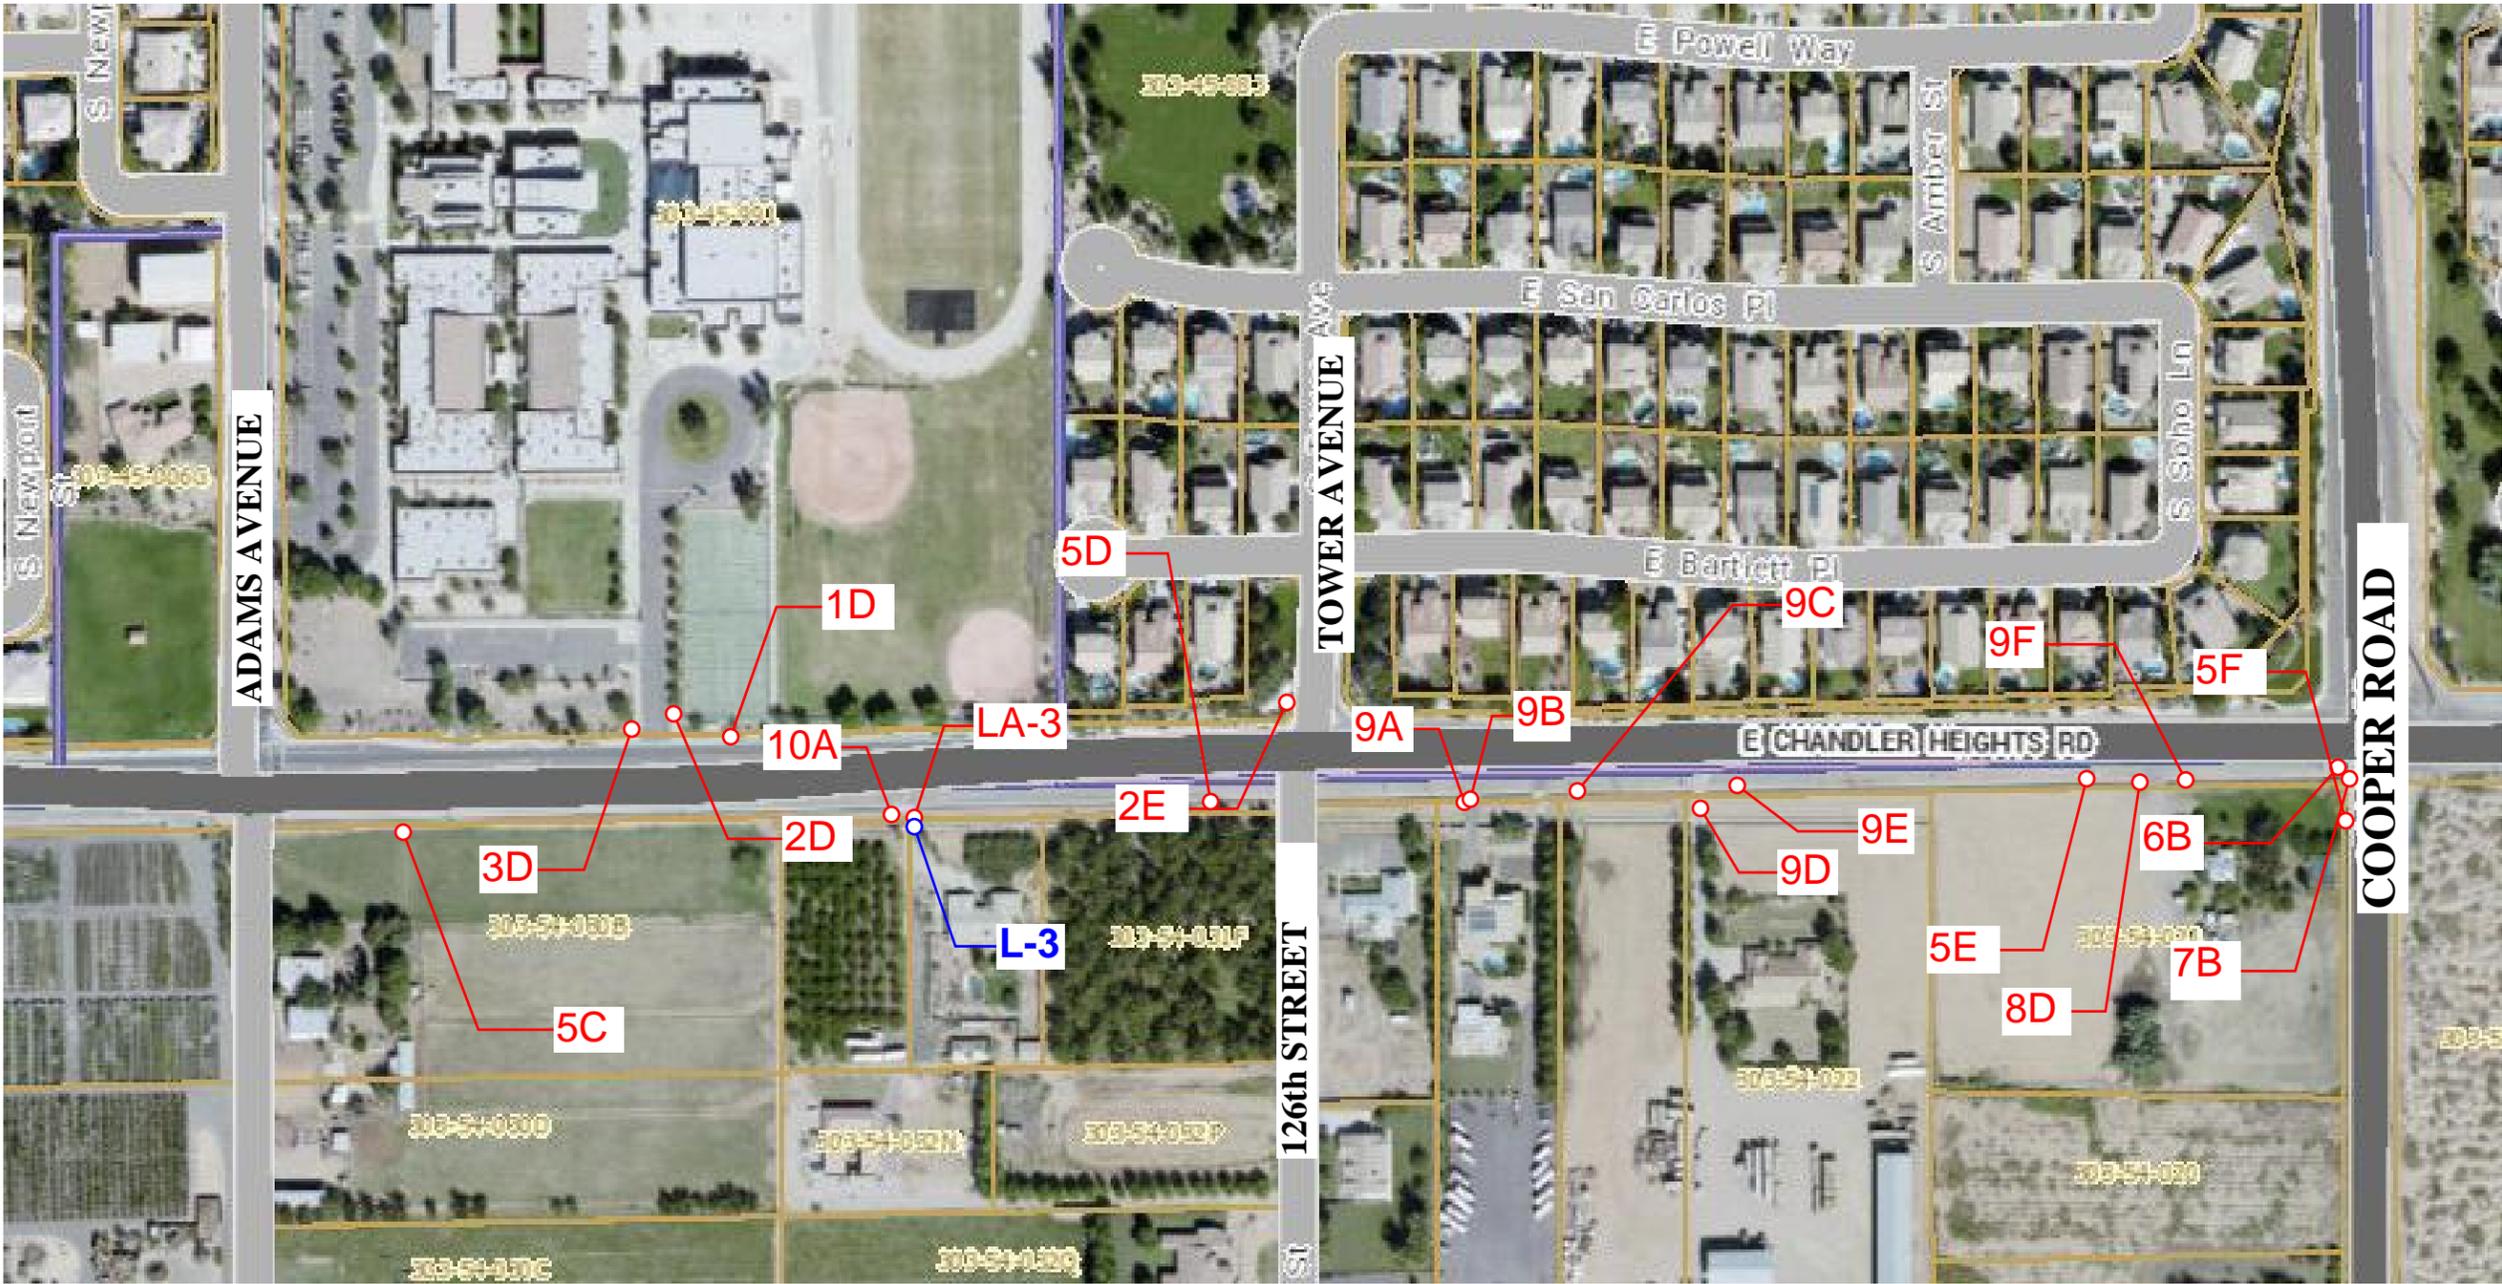
2

# Chandler Heights Road Improvements - Adams Avenue to Cooper Road

NO  
ASBESTOS  
DETECTED

NO LEAD  
PAINT  
DETECTED

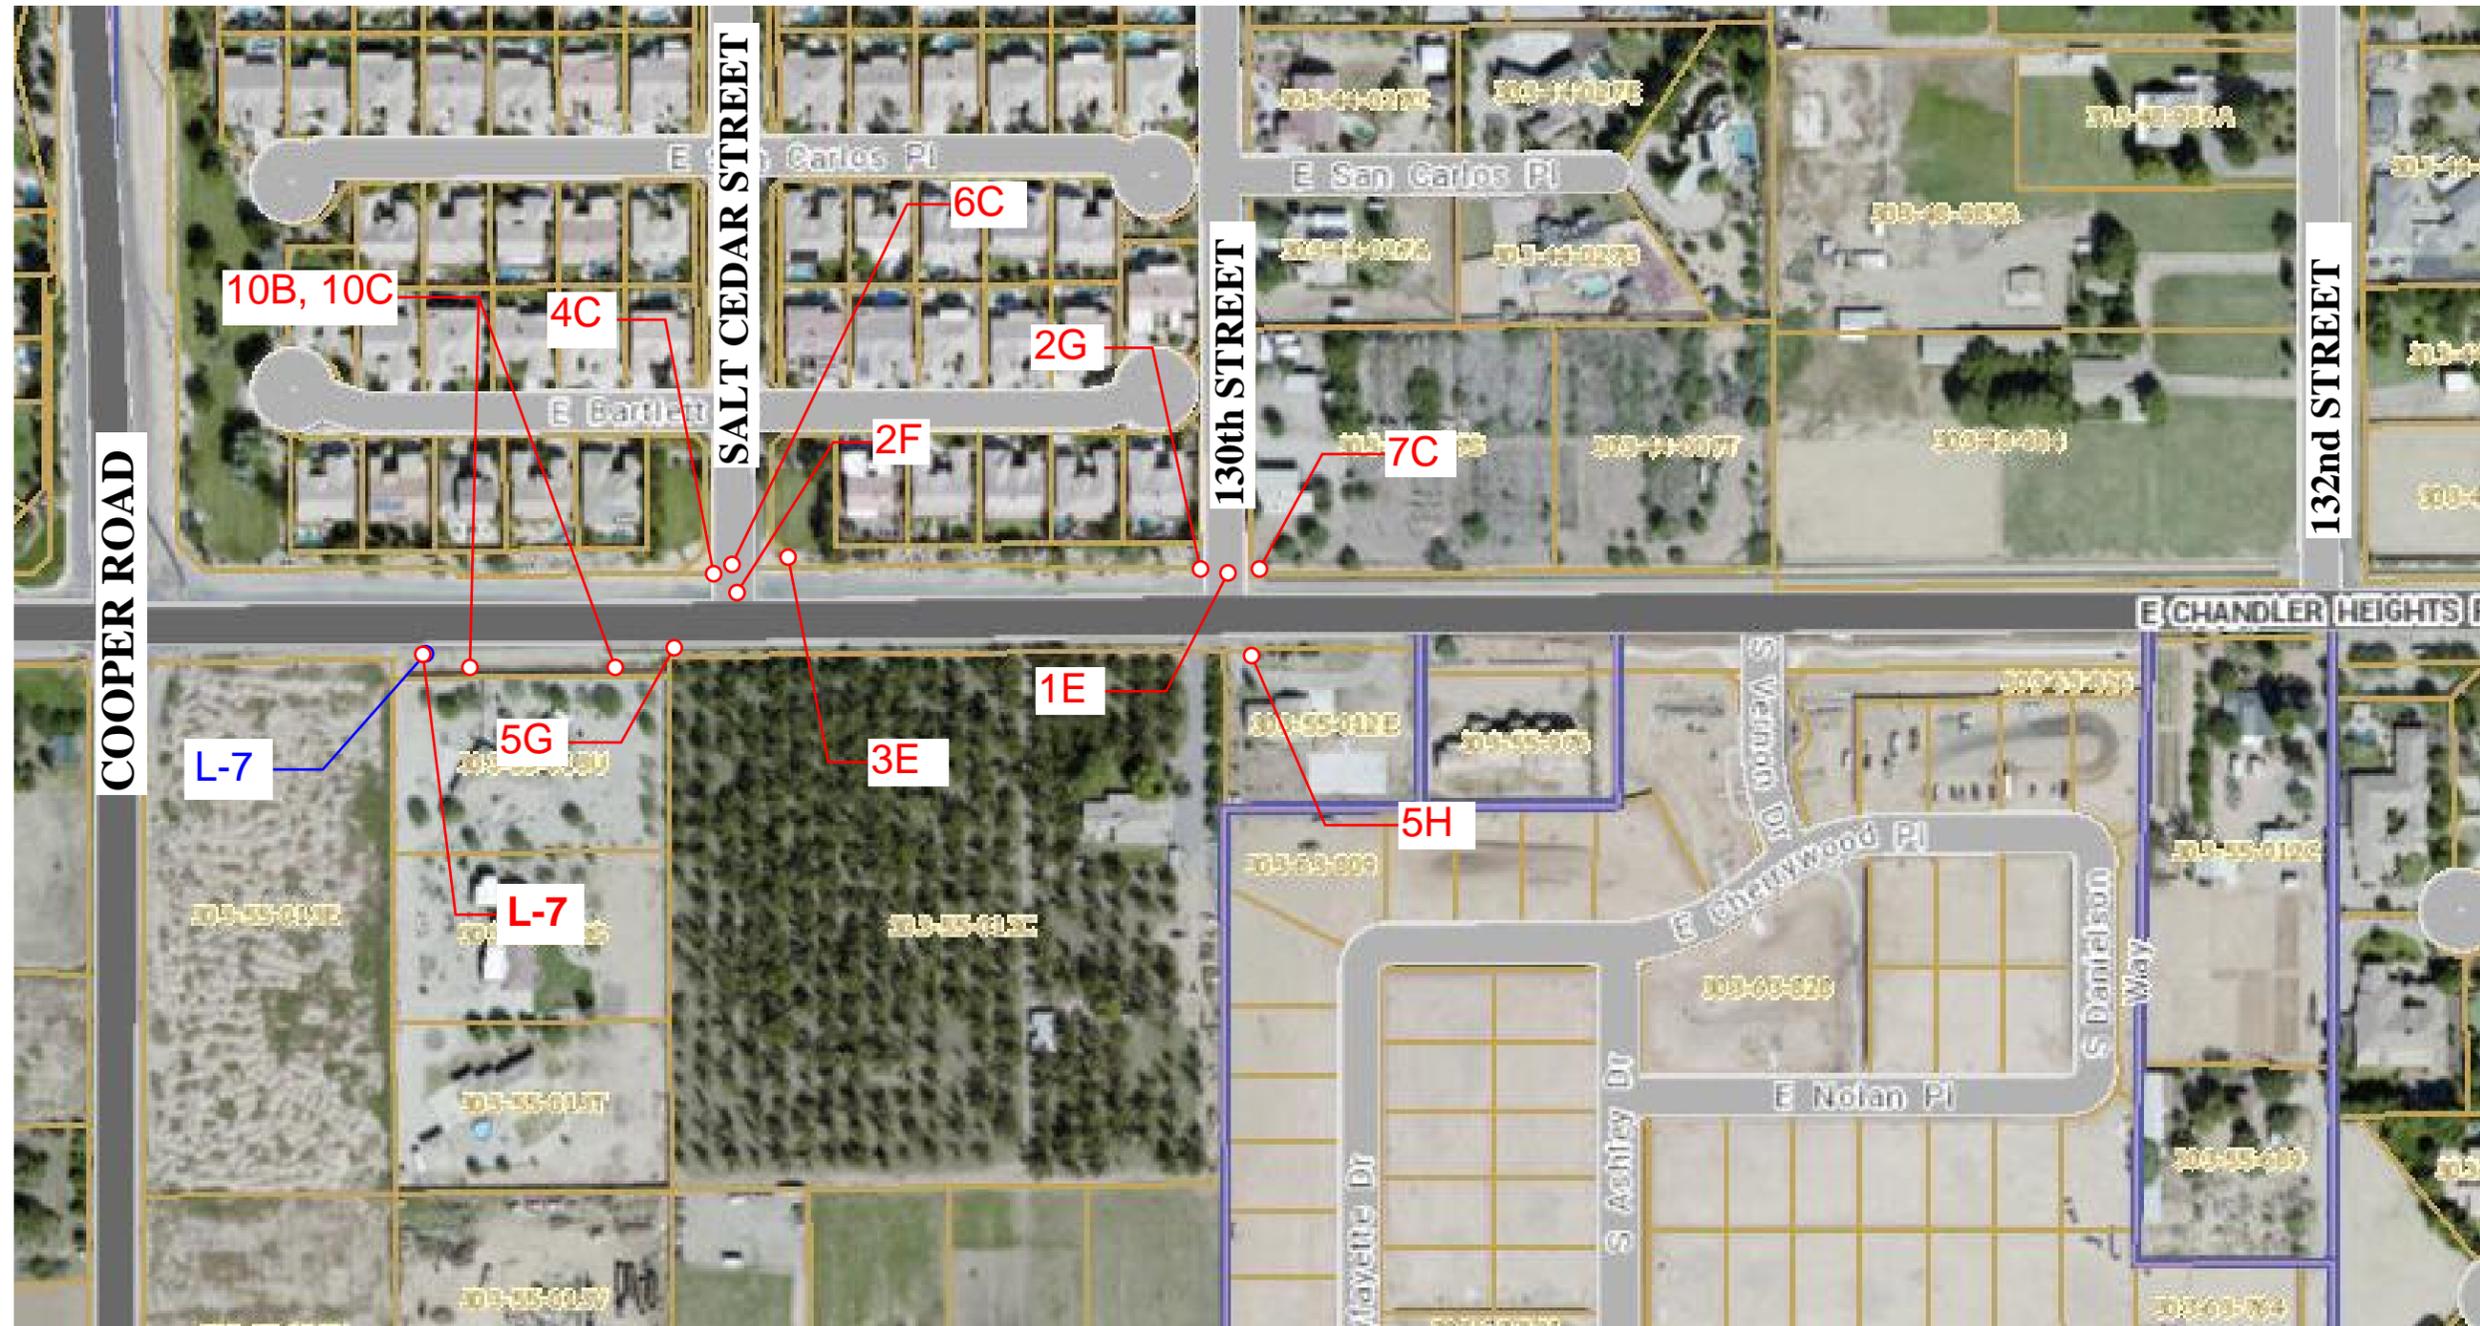
<b>THE GREEN WAY ENVIRONMENTAL GROUP, LLC</b> 3370 North Hayden Road Suite 123-187 Scottsdale, Arizona 85251			
<b>Sample Location Map</b>		<b>DATE</b>	<b>FIGURE</b>
Chandler Heights Road Improvements - McQueen Road to Gilbert Road Chandler, Arizona		July 2018	3

# Chandler Heights Road Improvements - Cooper Road to 132nd Street

**NO ASBESTOS DETECTED**

**NO LEAD PAINT DETECTED**

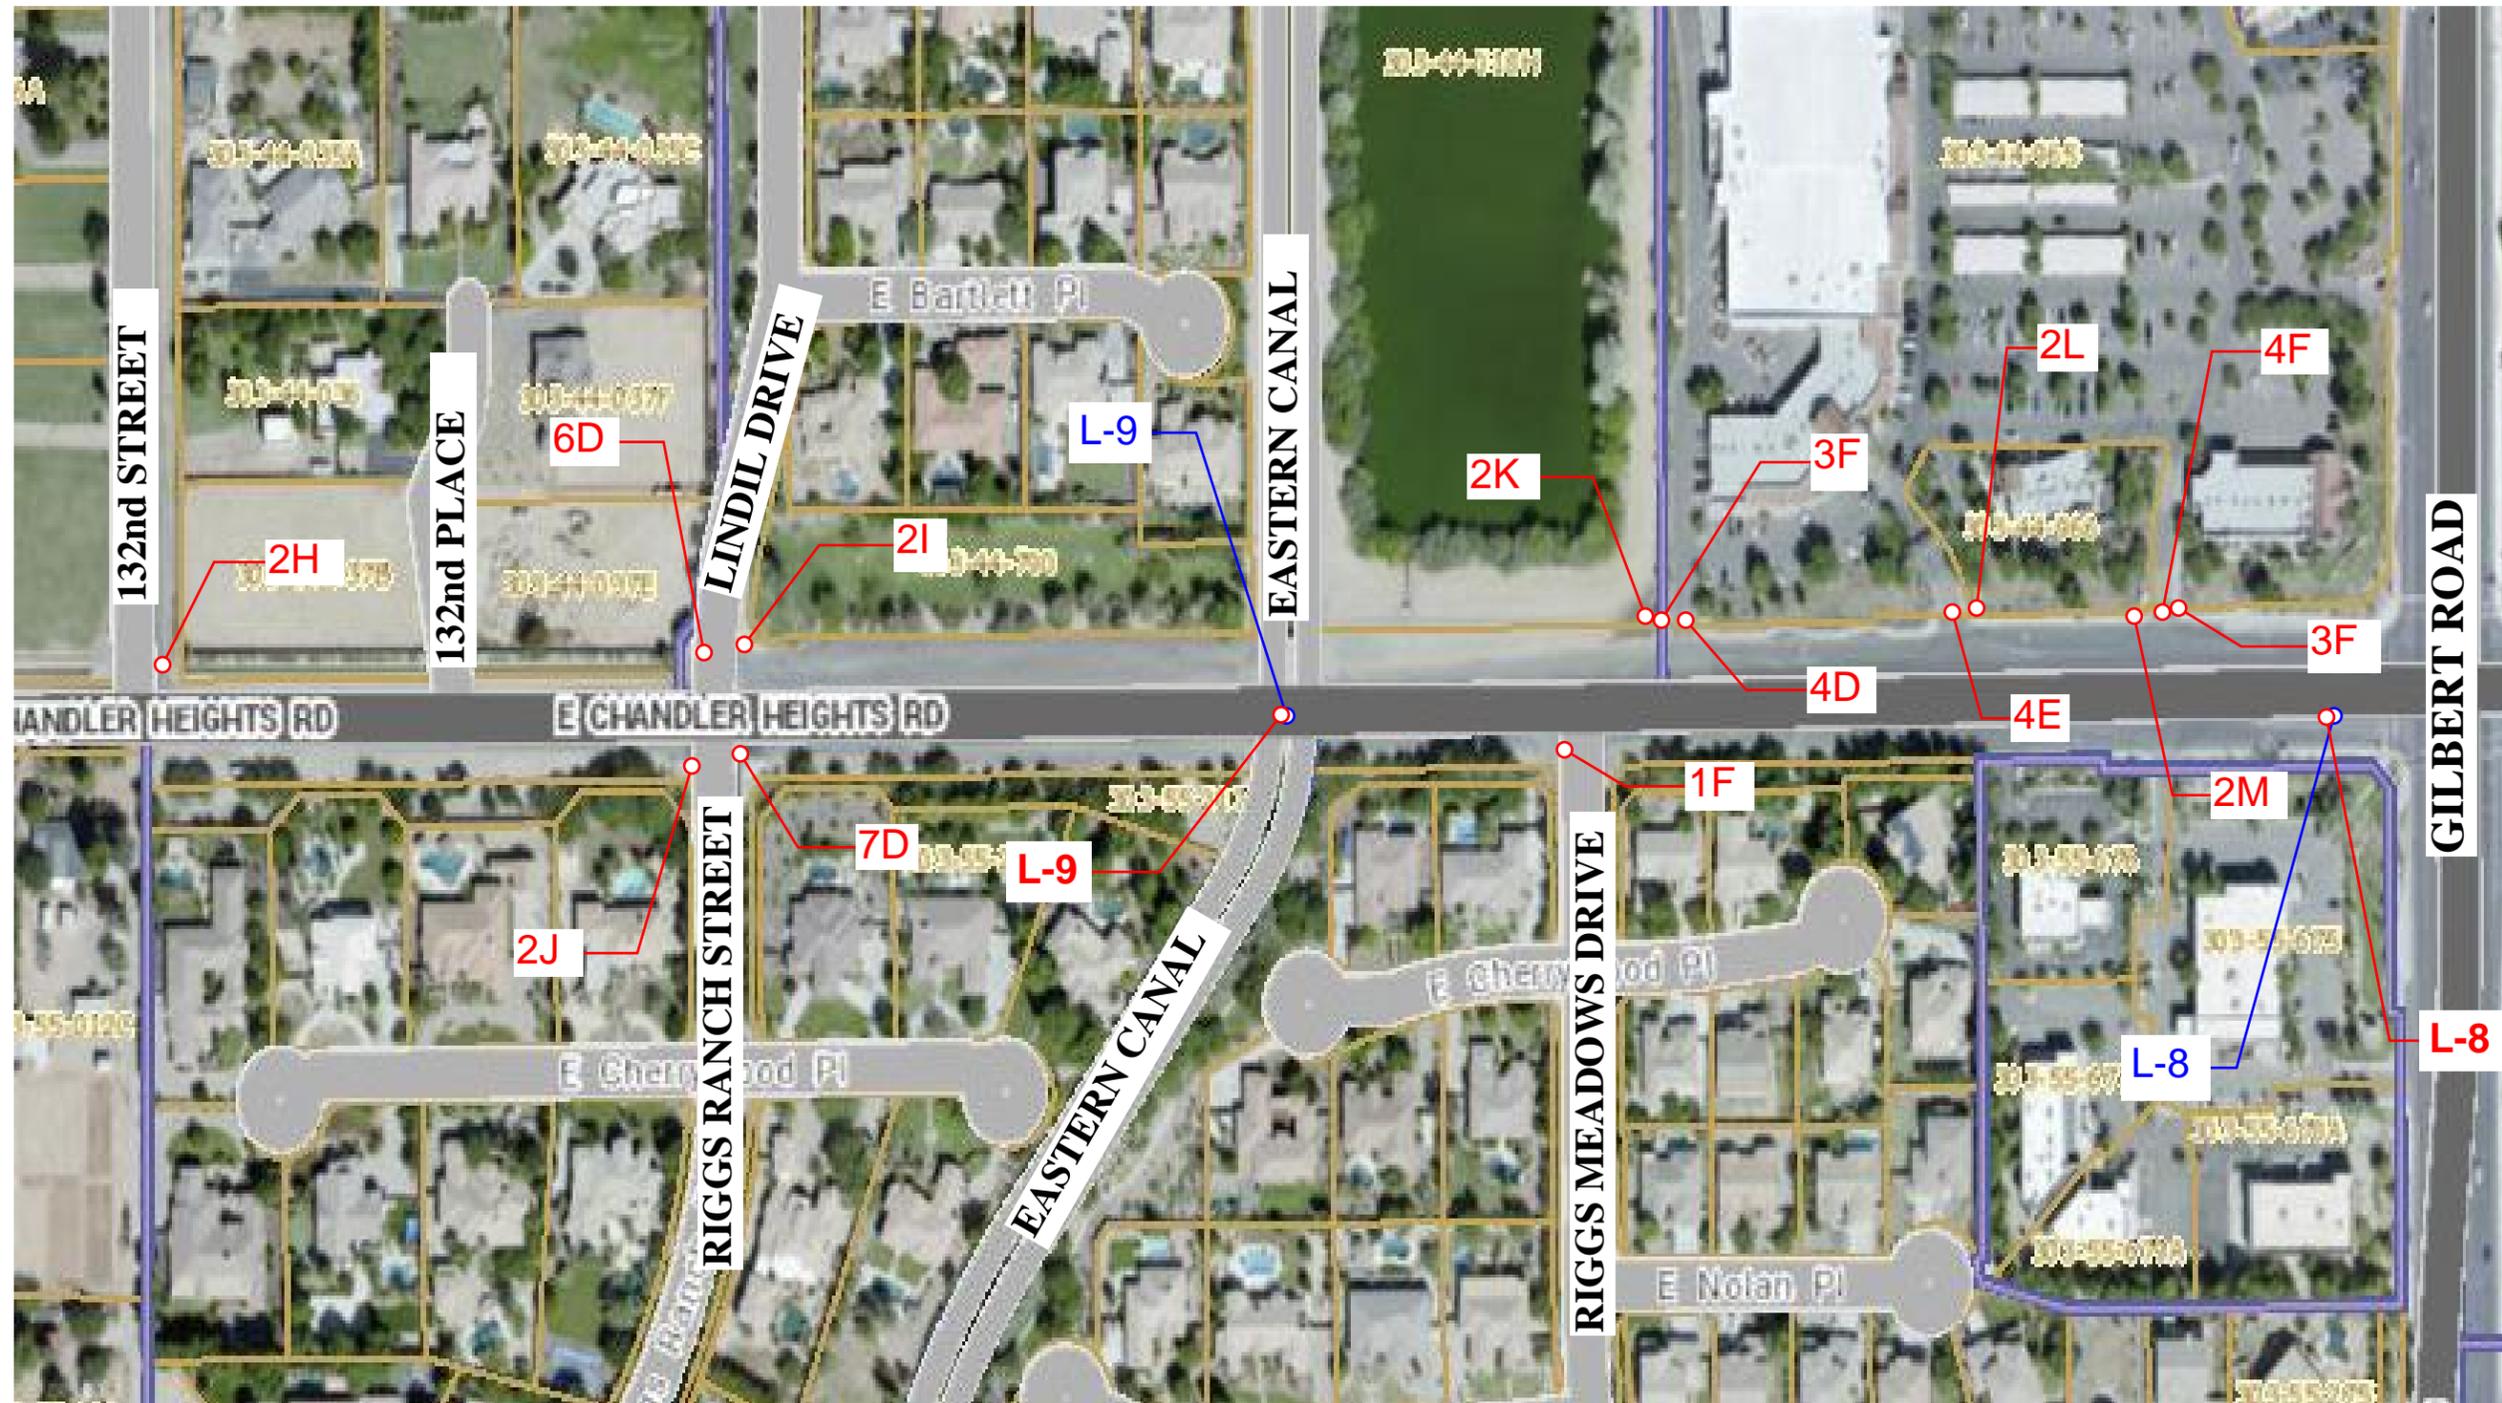
4

# Chandler Heights Road Improvements - 132nd Street to Gilbert Road

**NO  
ASBESTOS  
DETECTED**

**NO LEAD  
PAINT  
DETECTED**
