CAPITAL IMPROVEMENT PLAN

This section provides a thorough look into the quantity of existing assets and the timeline for which they will be in need replacement, and the appropriate (future inflation adjusted) value for each. The intent of the following section is to provide a starting point in quantifying the considerable financial value of the existing physical assets contained within the entire Department using a detailed system of matrices.

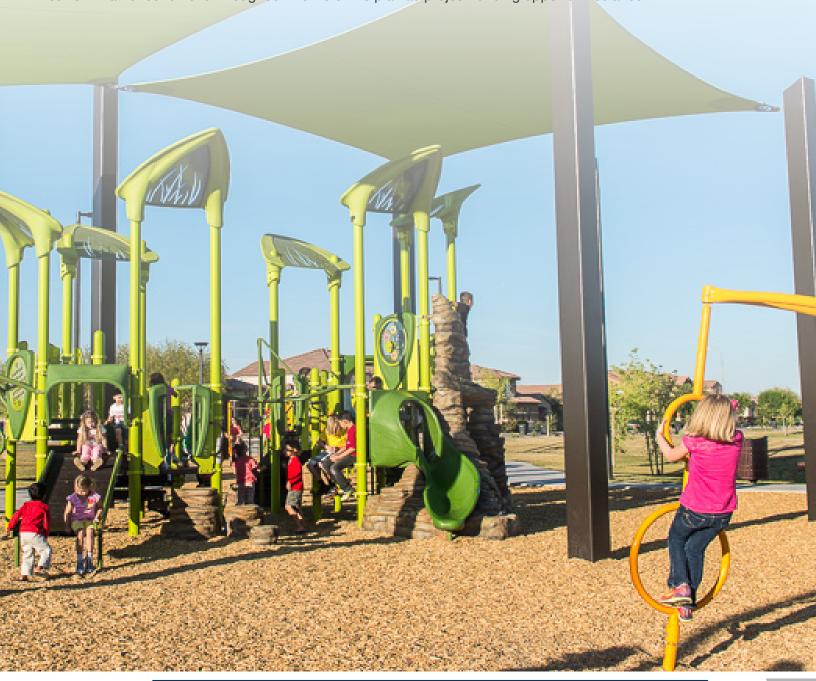
AMBERWOOD PARK

EXISTING AMENITY	φτγ	GRADE	COMMENTS
BASKETBALL COURT (LIGHTED)	1	3	Surfacing in good condition; signs of wear and minor cracking
BENCH	6	3	Seating and paint in good condition; minor signs of rust at mounting plates
DOG BAG STATION	4	3	Showing signs of fading and use
DRINKING FOUNTAIN	1	3	Good condition; minor signs of rust and water damage
IRRIGATION SYSTEM (AC)	16.47	3	Visual assessment only
LIGHTING (SITE, SPORTS, PED, ETC)	65	2	Light fixtures appear dated and showing signs of weathering
OPEN TURF AREA (AC)	9.6	2	Turf in average condition; low spots; regrading needed; some slopes and shaded areas lack quality turf growth
PLAYGROUND (SHADED)	1	3	Newer structures; shade small and not sufficient; minor low spots in surfacing
RAMADA	1	4	Good condition; little to no signs of fading or rust
SIGNAGE (PARK ENTRY)	2	3	Aging, faded, and paint refresh needed
SIGNAGE (REGULATORY)	5	3	Average condition; fading due to exposure

TRAIL - PAVED (MI)	0.54	3	Minor cracks and wear; damaged panels replaced
TRASH RECEPTACLE	18	3	Minor, non-structural damage through use
VOLLEYBALL COURT (SAND)	1	2	Poles and net aging; showing signs of rust/damage

FUTURE AMENITY, SERVICE OR STUDY	PRIORITY	ΦΤΥ	COMMENTS
CONSTRUCT TRAIL - PAVED (MI)	2	0.1	Replace sidewalks removed due to tree roots
DEMOLISH CONCRETE SIDEWALK	2	3,500	Trees causing uprooting, remove and replace
PERFORM SITE IRRIGATION ASSESSMENT	1	1	Evaluate condition and methods to improve
PERFORM SOIL AMENDMENTS AND AERATION	2	1	Improve turf soil with application of amendments and aeration
PERFORM TREE ASSESSMENT (BY ARBORIST)	2	1	Evaluate mature existing trees and establish replacement program
PERFORM TURF QUALITY ASSESSMENT	1	1	Evaluate worn areas and quality of existing turf slopes
RENOVATE/ REPLACE LANDSCAPE AND IRRIGATION	2	25000	Replace existing trees lost, replenish decomposed granite, improve irrigation system, etc

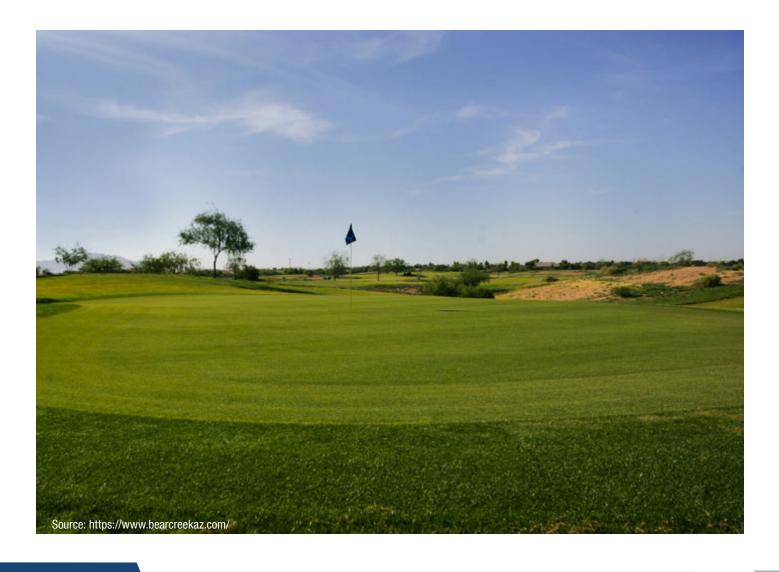
BLUE HERRON PARK

EXISTING AMENITY	φтγ	GRADE	COMMENTS
BBQ PIT/ GRILL	2	3	General signs of wear due to use; consider deep clean
BENCH	9	3	Wear and fading due to exposure; minor rust near mounting; some chipping of paint/coating
DRINKING FOUNTAIN	1	3	Significant wear due to use, no signs of rust
IRRIGATION SYSTEM (AC)	2.85	3	Visual assessment only
LIGHTING (SITE, SPORTS, PED, ETC)	24	4	Newer high pressure sodium fixtures; poles in good condition
OPEN TURF AREA (AC)	1.8	2	Slope; drainage/ maintenance issues with turf quality
PICNIC TABLE	4	4	Good condition; no obvious signs of fading and minor wear
PLAYGROUND (SHADED)	2	4	Surfacing settling
RAMADA	2	3	No signs of rust; minor fading and wear
SIGNAGE (PARK ENTRY)	1	2	Colors fading, signs of weathering; repaint needed
SIGNAGE (REGULATORY)	2	3	Fading due to exposure and age
TRAIL - PAVED (MI)	0.38	3	Good general condition; minor wear and cracking
TRASH RECEPTACLE	11	3	Signs of fading and wear; little to no signs of rust or significant damage

FUTURE AMENITY, SERVICE OR STUDY	PRIORITY	φτγ	COMMENTS
PERFORM SITE IRRIGATION ASSESSMENT	1	1	Evaluate condition and methods to improve
PERFORM SOIL AMENDMENTS AND AERATION	2	1	Improve turf soil with application of amendments and aeration

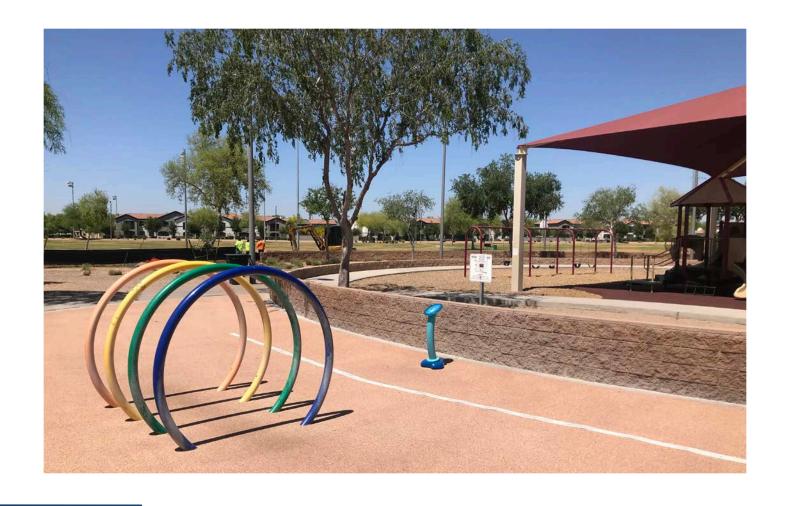
CITRUS VISTA PARK

EXISTING AMENITY	φτγ	GRADE	COMMENTS
BASKETBALL COURT (LIGHTED)	1	4	Good condition; hoops and poles like new
BBQ PIT/ GRILL	2	4	Good condition; signs of usage; consider deep clean
BENCH	16	4	Good condition; minor signs of use and exposure
BIKE RACK/ LOOP	2	4	Good condition; minor signs of wear
BOCCE BALL COURT	1	4	Good condition; surfacing displaced due to use
DOG BAG STATION	4	4	Good condition; minor signs of wear and fading due to exposure
DRINKING FOUNTAIN	2	3	Average condition; normal wear, minor water staining
HORSESHOE PIT	1	4	Good condition; surfacing displaced due to use
IRRIGATION SYSTEM (AC)	11.21	4	Visual assessment only
LIGHTING (SITE, SPORTS, PED, ETC)	35	4	Good condition, high pressure sodium fixtures
OPEN TURF AREA (AC)	6.9	4	Minor low and brown spots; turf in good condition
PICNIC TABLE	6	3	Signs of wear and weathering due to use
PLAYGROUND (SHADED)	2	4	Surfacing in good condition; equipment and shade in good condition

RAMADA	2	4	Good condition; no major signs of damage or aging
SIGNAGE (PARK ENTRY)	1	4	Good condition; colors vibrant
SIGNAGE (REGULATORY)	2	4	Good condition; minor signs of fading due to exposure
TRAIL - NON PAVED (MI)	0.29	3	Low spots, grading, and surfacing displaced
TRAIL - PAVED (MI)	0.55	4	Minor cracking and settling
TRASH RECEPTACLE	11	4	Good condition; minor signs of wear
VOLLEYBALL COURT (SAND)	1	4	Good condition; minor signs of wear and aging

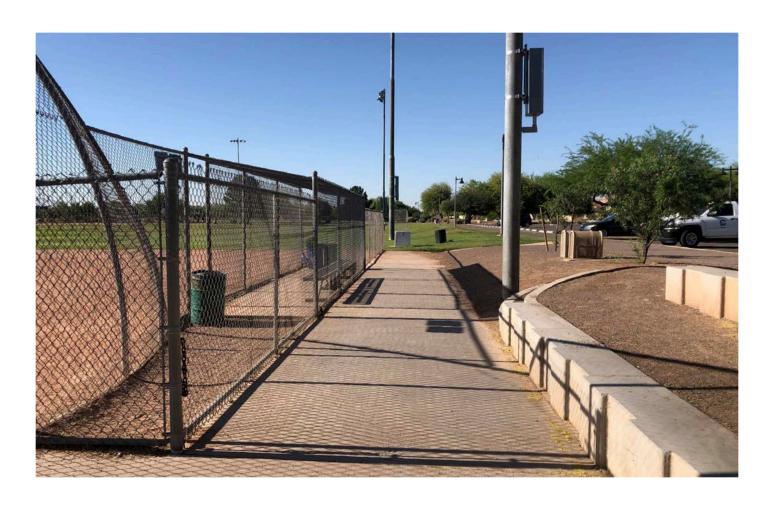
DESERT OASIS PARK

EXISTING AMENITY	φτγ	GRADE	COMMENTS
BBQ PIT/ GRILL	1	3	Signs of wear due to usage, consider deep clean
DRINKING FOUNTAIN	1	4	Good condition, signs of water damage due to use
IRRIGATION SYSTEM (AC)	0.72	3	Visual assessment only
LIGHTING (SITE, SPORTS, PED, ETC)	5	3	Signs of weathering
OPEN TURF AREA (AC)	0.1	4	Misc. low and brown spots, turf in good condition
PICNIC TABLE	4	4	Good condition, minor signs of wear due to usage
PLAYGROUND (SHADED)	1	4	Surfacing in good shape
RAMADA	1	4	Minimal shade provided, good condition, minimal fading and damage visible
SIGNAGE (PARK ENTRY)	1	3	Colors fading due to exposure
SIGNAGE (REGULATORY)	1	3	Signs of fading and wear due to exposure
TRAIL - PAVED (MI)	0.04	3	Signs of wear, minor cracking/settling
TRASH RECEPTACLE	2	3	Signs of usage and exposure
VOLLEYBALL COURT (SAND)	1	3	Average condition, signs of heavy usage and wear

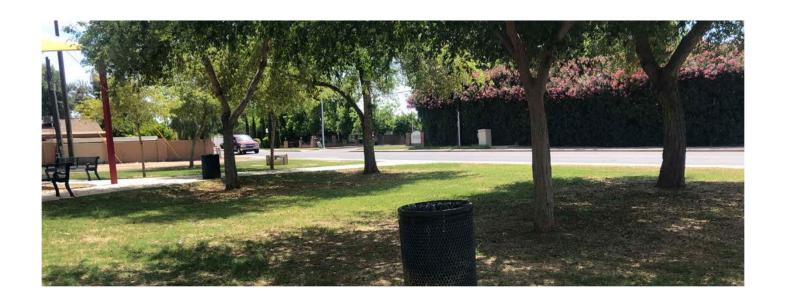
ESPEE PARK

EXISTING AMENITY	ϘΤΥ	GRADE	COMMENTS
BASEBALL FIELD (LIGHTED)	3	3	Field 1 — in-field in good condition, out field needs attention; Field 2-3 in good condition, consider more access paths to the fields
BBQ PIT/ GRILL	3	3	Normal wear and tear due to use; consider deep clean
BENCH	13	3	Normal wear through usage and age
BIKE RACK/ LOOP	3	3	Normal wear through usage and age
BIKE/ SKATE PARK (SF)	30,000	4	Well maintained; consider improving perimeter landscape and fence (rusted, needs paint)
BLEACHERS	6	3	Seating area and shade at ball fields is in good condition
DOG BAG STATION	3	3	Fading and wear due to exposure and general use
DRINKING FOUNTAIN	4	3	Average condition; typical signs of wear
FLAG POLE	1	3	Showing signs of age and weathering
IRRIGATION SYSTEM (AC)	32.77	3	Visual assessment only
KIOSK (INTERPRETIVE)	1	3	Good condition; light fading
LIGHTING (SITE, SPORTS, PED, ETC)	55	3	Poles and high pressure sodium fixtures show signs of age and weathering

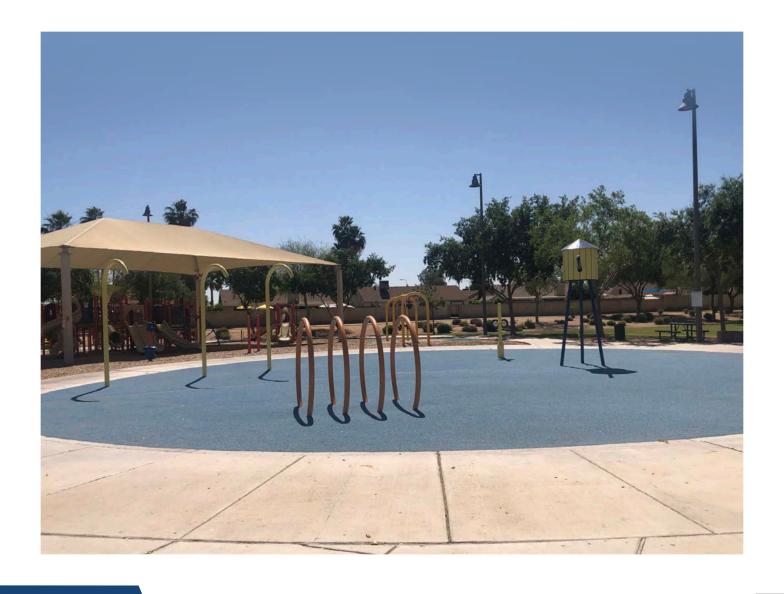
FOLLEY MEMORIAL PARK

EXISTING AMENITY	ΦΤΥ	GRADE	COMMENTS
BASKETBALL COURT (LIGHTED)	2	4	Court surface, hoops, and posts in good condition
BBQ PIT/ GRILL	9	3	Obvious signs of usage; consider deep clean
BENCH	23	3	Signs of fading due to exposure and age; normal usage
BIKE RACK/ LOOP	1	4	Good condition; no visible signs of chipping/rust
BLEACHERS	5	3	Good condition; minor signs of wear
DOG BAG STATION	4	3	Faded due to usage and age
DRINKING FOUNTAIN	2	3	Minor signs of water and rust damage
IRRIGATION SYSTEM (AC)	22.86	3	Visual assessment only
LIGHTING (SITE, SPORTS, PED, ETC)	63	3	Older poles and fixtures
OPEN TURF AREA (AC)	3.1	3	Low and brown spots; uneven in areas
PARKING LOT (SPACES)	271	2	Signs of cracking, chipped, and weathered surfacing
PICNIC TABLE	45	3	Most in good condition; minor wear and chipping
PLAYGROUND (SHADED)	1	4	Surfacing settling
RAMADA	9	3	Mix of old and new; older showing visible signs of age/wear due to use and exposure; consider replacement

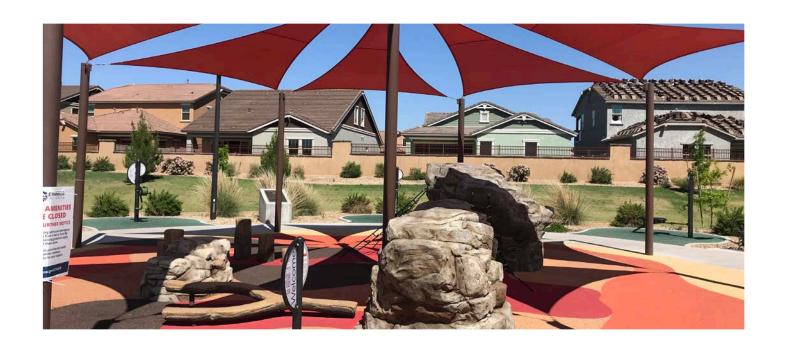
HOOPES PARK

EXISTING AMENITY	φτγ	GRADE	COMMENTS
BASKETBALL COURT (LIGHTED)	1	4	Normal wear from use; little to no cracking
BBQ PIT/ GRILL	4	3	Normal wear from use
BENCH	5	4	Minor chipping and fading due to use and exposure
BIKE RACK/ LOOP	1	3	Clearly visible signs of rust and chipping
DOG BAG STATION	3	3	Faded due to exposure and age
DRINKING FOUNTAIN	1	3	Visible minor water and rust damage
IRRIGATION SYSTEM (AC)	12.54	3	Visual assessment only
LIGHTING (SITE, SPORTS, PED, ETC)	24	4	Newer poles and fixtures
OPEN TURF AREA (AC)	9.8	3	Low/bare spots, inconsistent growth on slopes and shaded areas
PICNIC TABLE	14	3	Normal wear and chipping from use
PLAYGROUND (SHADED)	1	4	Surfacing settling; structure in good condition
RAMADA	3	3	Signs of wear and aging
SIGNAGE (PARK ENTRY)	2	3	Faded due to exposure and age
SIGNAGE (REGULATORY)	4	3	Faded from exposure and use
TRAIL - PAVED (MI)	0.41	3	Normal wear; minor signs of cracking

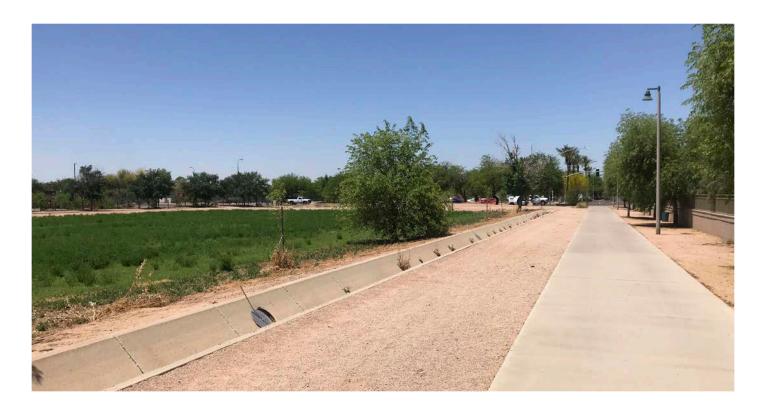
MAGGIO RANCH PARK

EXISTING AMENITY	φτγ	GRADE	COMMENTS
BASKETBALL COURT (LIGHTED)	1	2	Consider resurfacing
BBQ PIT/ GRILL	1	3	Normal signs of use; consider deep clean
BENCH	4	3	Visible chipping of paint/coating from use
DOG BAG STATION	5	3	Fading due to exposure and age
DRINKING FOUNTAIN	1	3	Minor signs of water damage/staining
IRRIGATION SYSTEM (AC)	5.28	3	Visual assessment only
LIGHTING (SITE, SPORTS, PED, ETC)	12	3	Dated high pressure sodium lighting fixtures throughout park
OPEN TURF AREA (AC)	3.2	3	Inconsistent turf quality; possible irrigation issues
PICNIC TABLE	5	2	Worn, rusting, uneven surfaces
PLAYGROUND (SHADED)	2	3	Two of the same 2-5 structures; no 5-12 structures
SIGNAGE (PARK ENTRY)	1	3	Good condition
SIGNAGE (REGULATORY)	3	3	Good condition
TRAIL - PAVED (MI)	0.13	3	Tree roots encroaching on sidewalks
TRASH RECEPTACLE	18	3	Signs of use, fading, chipping, etc.
VOLLEYBALL COURT (SAND)	1	2	Needs additional sand, no net, tree debris

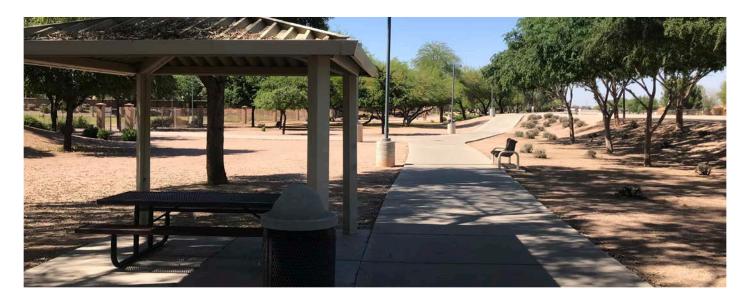
PASEO VISTA RECREATION AREA

EXISTING AMENITY	φτγ	GRADE	COMMENTS
ARCHERY RANGE	1	3	Visible signs of wear from usage
BENCH	37	4	Good condition
BIKE RACK/ LOOP	4	3	Visible signs of wear from usage
DISC GOLF COURSE	1	3	Signs of fading due to exposure and use
DOG BAG STATION	17	3	Signs of use and discoloration due to exposure
DOG PARK	1	4	Significant turf wear; amenities in good condition
DRINKING FOUNTAIN	2	3	Minor water/rust damage
IRRIGATION SYSTEM (AC)	18.50	4	Visual assessment only
LIGHTING (SITE, SPORTS, PED, ETC)	99	3	Newer poles and fixtures; signs of fading due to exposure
MAINTENANCE YARD/ BUILDING	1	3	Appears to be in average state of condition
OPEN TURF AREA (AC)	1.0	3	Multiple low/bare spots; uneven turf growth
PARKING LOT (SPACES)	416	2	Surfacing chipped and quite rough finish, millings
PICNIC TABLE	8	3	Normal wear and usage patterns
PLAYGROUND (NON-SHADED)	2	4	Equipment in good condition, playability limited
PUBLIC ART	3	3	Exposure has created some visible fading

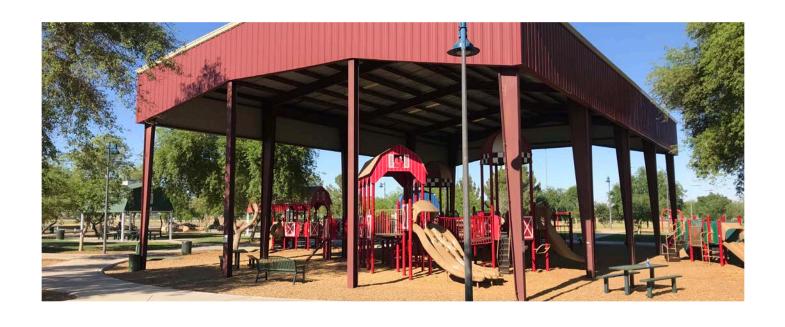
VALENCIA PARK

EXISTING AMENITY	φτγ	GRADE	COMMENTS
BASKETBALL COURT (LIGHTED)	1	4	Good condition
BBQ PIT/ GRILL	2	3	Normal wear from usage
BENCH	15	4	Good condition
BIKE RACK/ LOOP	1	4	Good condition
DOG BAG STATION	4	3	Fading and wear from exposure and usage
DRINKING FOUNTAIN	1	3	Good condition; minor signs of water damage
HORSESHOE PIT	1	4	Good condition; surface displaced due to use
IRRIGATION SYSTEM (AC)	9.35	4	Visual assessment only
LIGHTING (SITE, SPORTS, PED, ETC)	27	4	Good condition
OPEN TURF AREA (AC)	5.1	4	Good condition; minor brown spots
PICNIC TABLE	8	4	Good condition
PLAYGROUND (NON-SHADED)	1	4	Good condition; minor wear and settling
PLAYGROUND (SHADED)	2	4	Good condition; minor wear and settling
PUBLIC ART	2	4	Circular and drainage area features
RAMADA	2	4	Good condition; minor signs of fading/exposure
SIGNAGE (PARK ENTRY)	1	4	Good condition
SIGNAGE (REGULATORY)	4	3	Minor fading due to exposure
TRAIL - PAVED (MI)	0.63	4	Good condition
