CHAPTER 2

PARKS & FACILITIES ASSESSMENTS

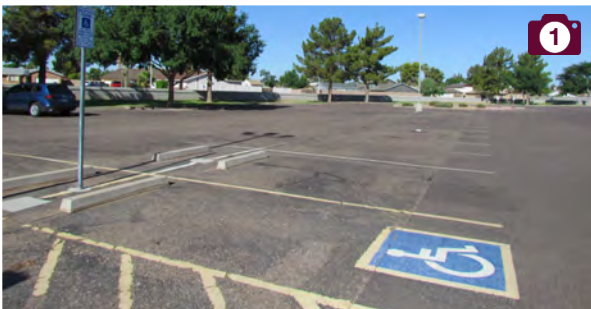
Parking Lot

The adjacent parking lot pavement is in average condition. The asphalt-concrete pavement cracks range from 1/2" to 1" in width. The drive aisles have been resurfaced in the past. The parking areas appear to be original pavement. A seal coat of all surface cracks every three years is recommended. The existing drive-aisle pavement and subbase can age another 10 years with recommended seal coat due to positive drainage conveyance.

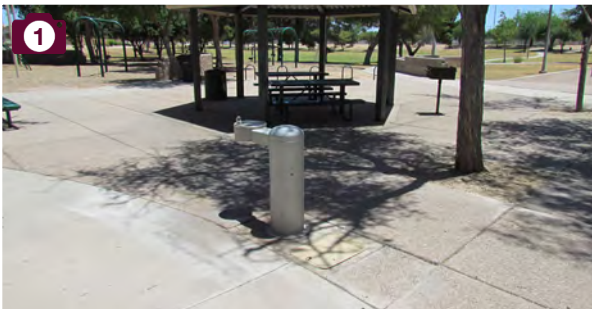
Sidewalk and concrete plaza areas

The concrete sidewalk is in average condition as there are several cracked panels throughout the pathways and plaza areas.

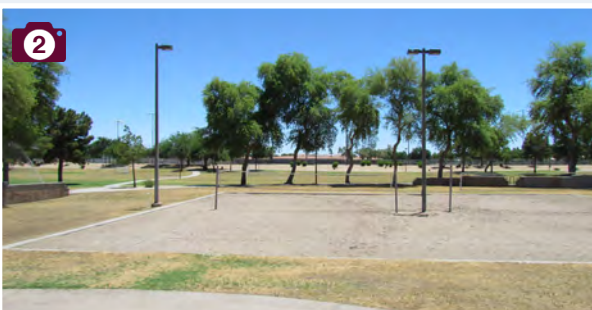
Basketball and Sand Volleyball Courts

The concrete post-tension court and sand volleyball court are in good condition. The courts have high-pressure sodium lighting. LED fixture replacement for court lighting is recommended.

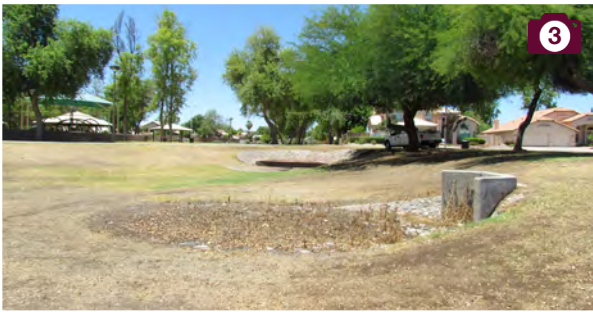
Overall Drainage

The park has two large turf areas in the south area of the park. The east half provides retention storage for offsite storm water runoff from Sycamore Place and Meadows Drive. This basin has two storm drain outfalls along the Sycamore Place frontage. The southern portion of the east basin has a storm drain outfall at the midpoint of Meadows Drive.

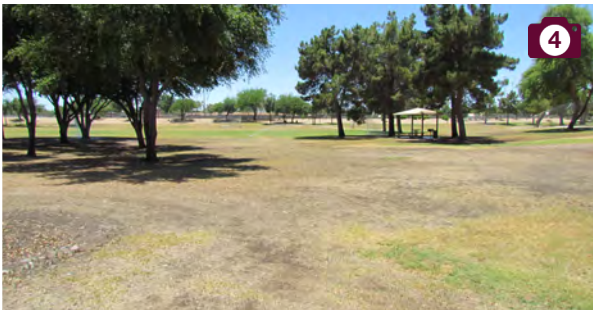
South Turf Area (east half)

The south turf area is in poor condition with several worn and dead zones. The worn condition of slopes is due to lack of irrigation maintenance, not activity. The ground is very compacted throughout. An aeration and soil agronomy test is recommended to evaluate soil condition.

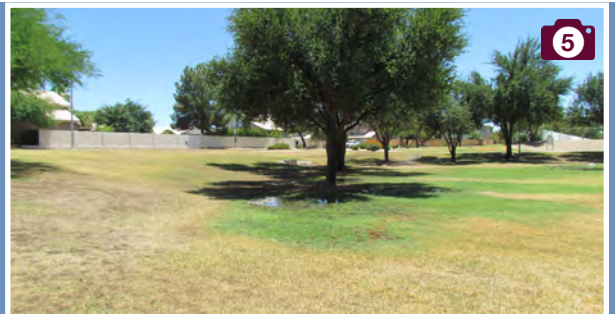
North Turf Area (west half)

The south turf area is in poor condition with several worn and dead zones. The ground appears very compacted throughout. An aeration and soil agronomy test is recommended to evaluate soil condition.

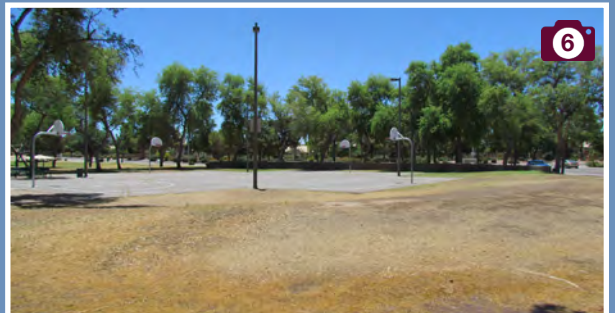
Turf Area around Playground and Court Area

The turf is in poor condition with several worn and dead zones. The ground appears very compacted throughout. An aeration and soil agronomy test is recommended to evaluate soil condition. The worn condition of slopes is due to lack of irrigation maintenance not activity.

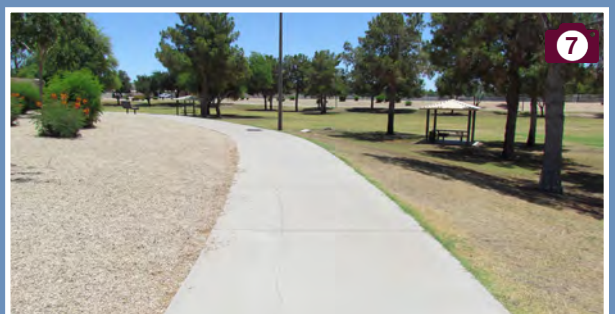
Sidewalk

Concrete sidewalk has some cracking throughout.

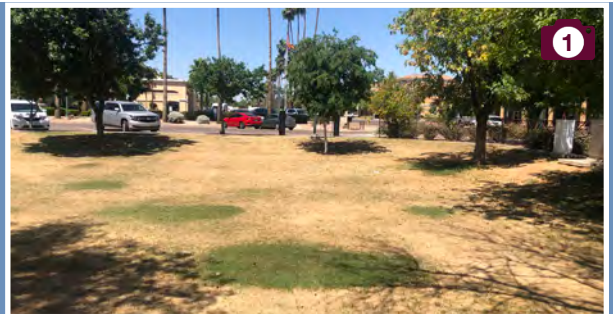
Turf Areas

The turf areas have patches of yellow with some green areas. Ground is pretty compacted throughout. Large shade tree canopies have contributed to non growth turf areas. The condition is due to lack of irrigation maintenance not activity. An aeration and soil agronomy test to evaluate soil condition and recommendations for amendments is suggested

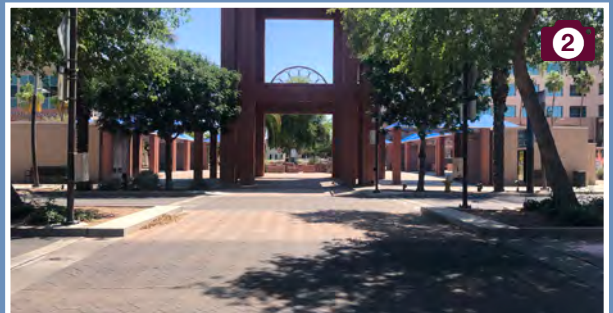
Sidewalk and Pavers at Plaza Areas

The concrete sidewalk is in good condition. Pavers are in good condition with no noticeable settlement.

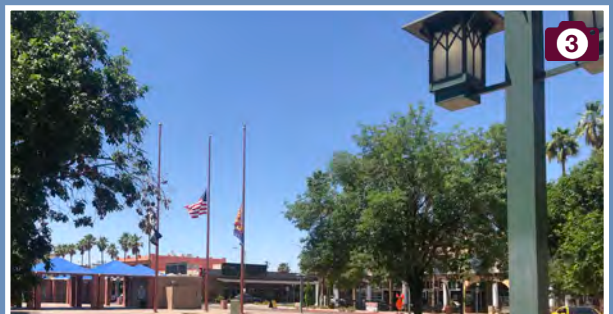
Site Lighting

The site lighting utilizes high pressure sodium. The light fixtures are architectural themed fixture and replacement is recommended if the entire park was to be redesigned.

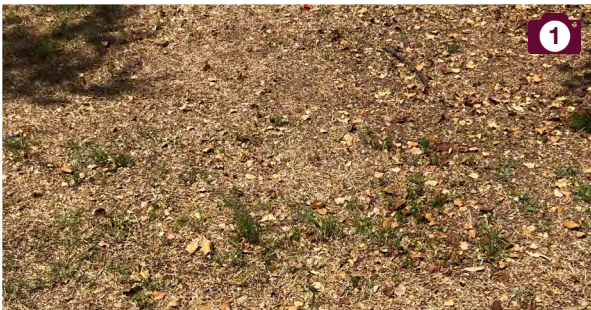
Turf Area

The turf has worn areas throughout and is in average condition. Large mature trees with large shade canopies have contributed to the non-growth areas. The ground is compacted throughout. An aeration and soil agronomy test to evaluate soil condition and recommendations for amendments is suggested.

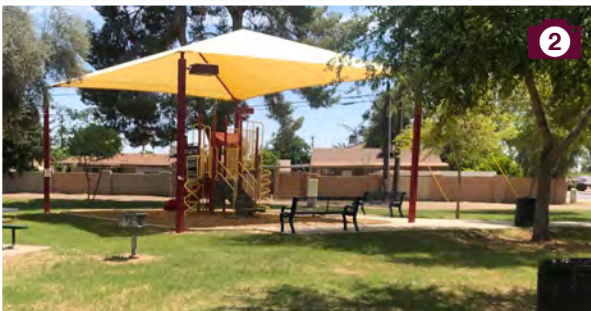
Site Lighting

The site lighting is high pressure sodium fixtures with a combination of shoebox and decorative fixtures throughout the park. Recommend deferring replacement of fixtures with LED until the current fixtures reach SUSTAINABLE PROJECTS.

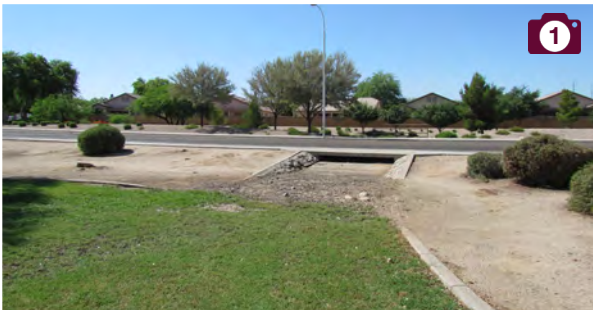
Overall Drainage

The parking areas have positive drainage to the east and west turf drainage basins. The surface drainage is conveyed via concrete scupper pans. Offsite Drainage is conveyed to the south turf basin by scupper.

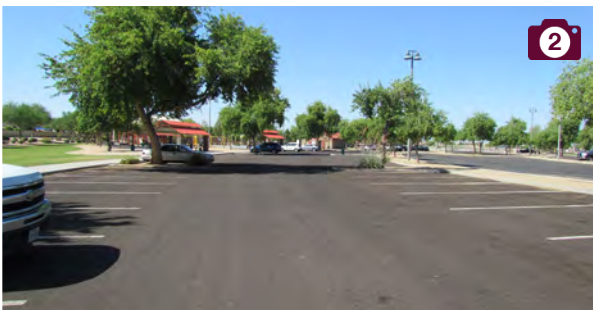
Central Parking Area

The central parking area has recently been sealed and restriped. The parking lot is in excellent condition.

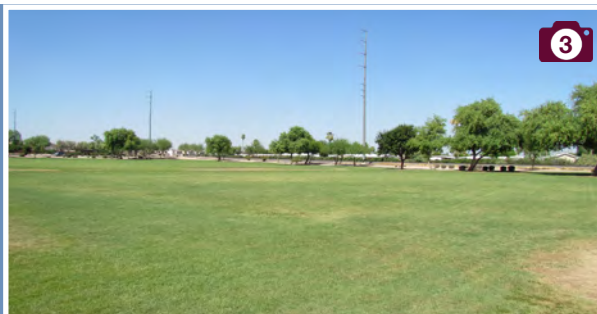
South Turf Area

This turf area is in average condition. There are worn areas on the middle berm as flood irrigation does not reach this area. There are also worn areas on the sideslope areas around the skate park area. The condition of slopes is due to lack of irrigation maintenance not activity. An aeration and soil agronomy test is recommended to evaluate soil conditioning.

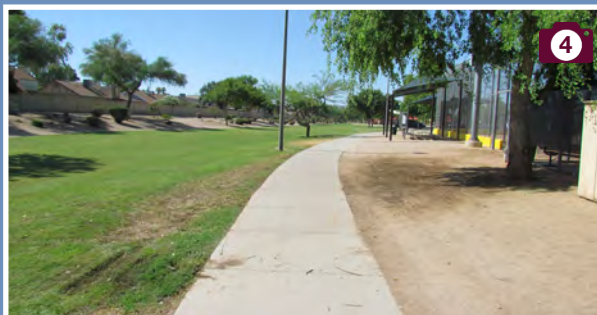
Sidewalk

The concrete sidewalk is in good condition. There are a few panels that show some vertical separation.

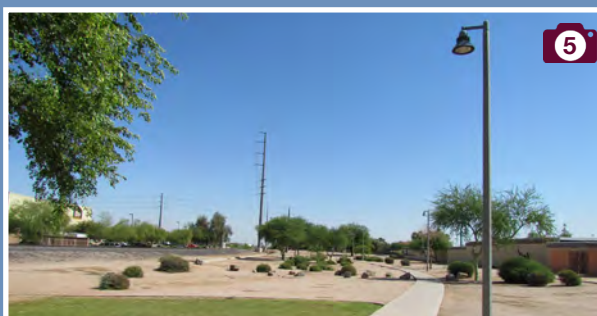
Site Lighting

The pathway lighting is high-pressure sodium. Fixtures appear to be in good shape.

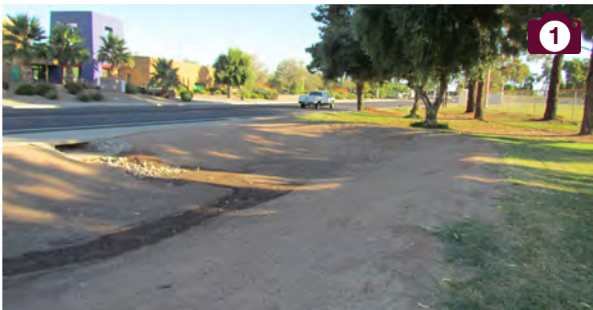
Overall Drainage

The park is self-retaining for the onsite storm water. There is a small dirt basin along South Hamilton Street that has a scupper providing offsite runoff collection.

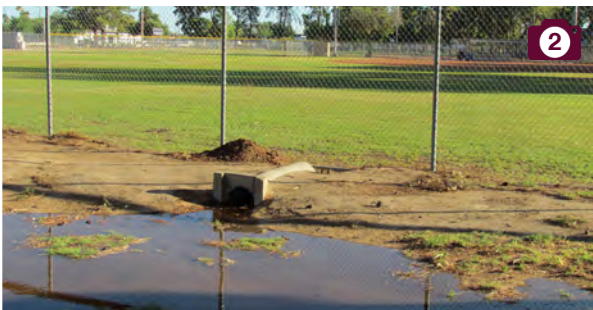
Turf at Fields

The turf in the field areas is in average condition. The fields are flood irrigated. An aeration and soil agronomy test is recommended to evaluate soil conditioning.

The turf within the ramada area is in average condition. There are several worn or non-growing dirt areas due to the foot traffic and the shade from mature trees. The ground is very compacted throughout. An aeration and soil agronomy test is recommended to evaluate soil condition.

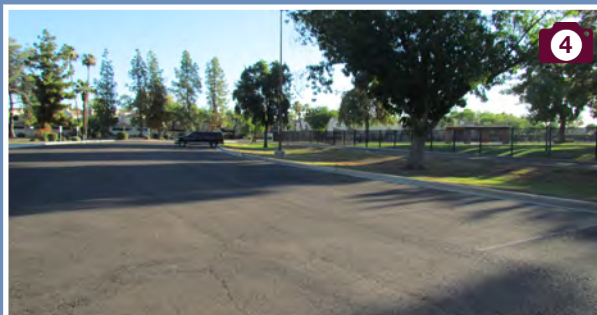
Southwest Parking area off Hamilton Street

The pavement is in moderate condition. Lot contains new LED fixtures for lighting. A seal coat of all surface cracks every three years is recommended. The existing pavement and subbase can age another 10 years with recommended crack seal/seal coat due to positive drainage conveyance.

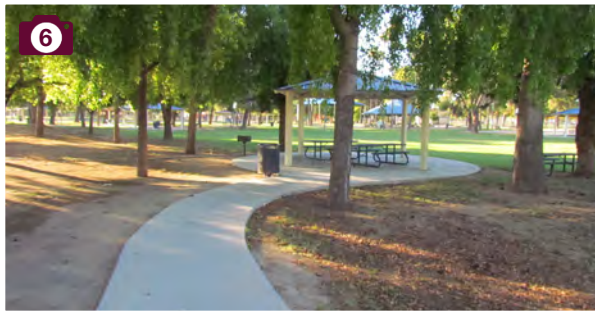
Established Trees

Several areas with established trees located near the sidewalk have some cracking/heaving. Some have been replaced by the City, but they are being replaced in the same location as the existing tree and will cause further uprooting in the future. A concrete sidewalk relocation to provide better separation from the tree root zone is recommended.

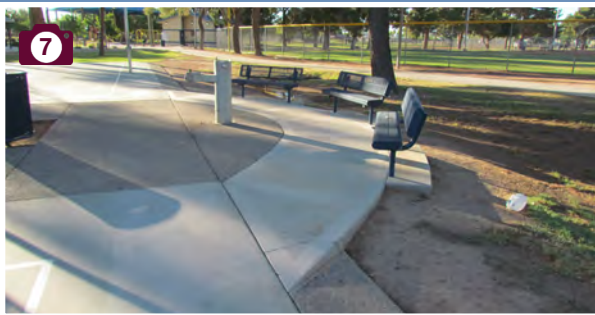
Sidewalk

The concrete sidewalk is in good condition. There are a few panels with cracking and vertical separation.

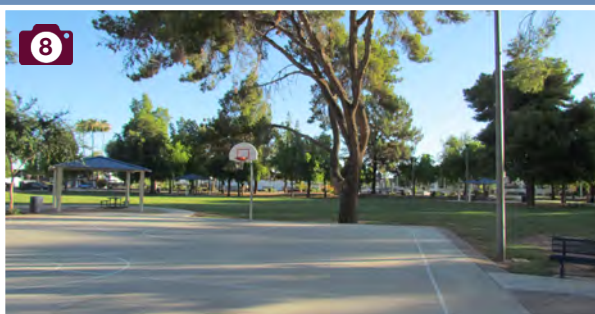
Basketball Court

The concrete post-tension courts are in good condition and the lighting has new LED fixtures on stone poles.

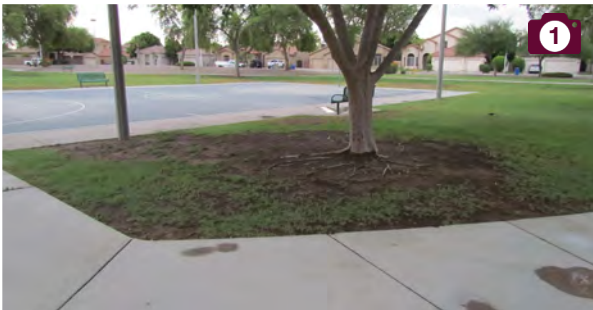
Playground Turf Area

The south east turf area has several worn/non-growing areas on the berm slopes and in the areas with established trees. The condition is due to lack of irrigation maintenance not activity. The area appears very compacted throughout. An aeration and soil agronomy test to evaluate soil condition is recommended. Additionally, reducing turf and adding decomposed granite in areas with established shade trees is also recommended.

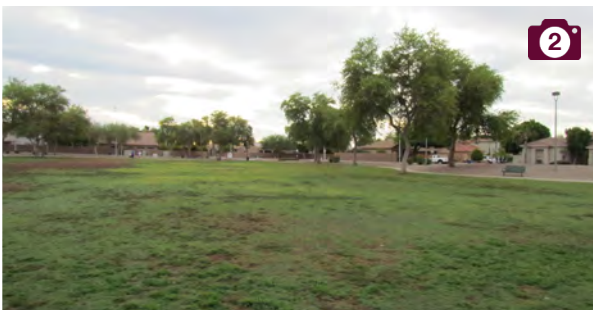
East Turf Area

The east turf area is in average condition with several worn areas. The area appears very compacted throughout. An aeration and soil agronomy test to evaluate soil condition is recommended.

The concrete sidewalk has some cracking throughout.

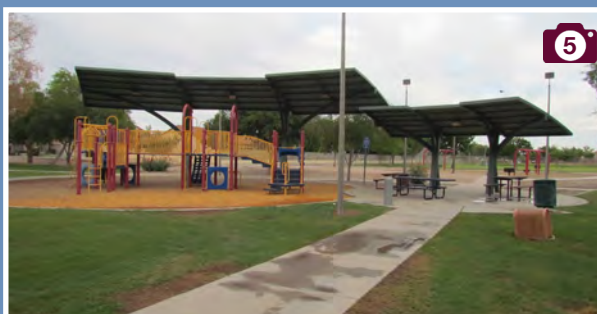
Playground

The playground area is in good shape and the header curbs and sidewalk areas are in average condition. The play equipment is also in average condition.

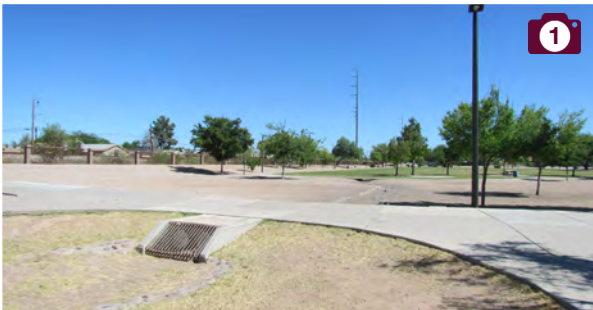
Overall Drainage

The original approach to the storm drain runoff, distribution, and storage of the offsite drainage was poorly engineered in regards to the park. All of the storm drain outlets are without headwalls and exposed and failing or corrugated metal pipe. It is recommend that re-evaluating the drainage areas in this park be undertaken. Removing the drainage structure and pipe near the playground and redeveloping the central drainage area in the primary play and amenity area is also recommended.

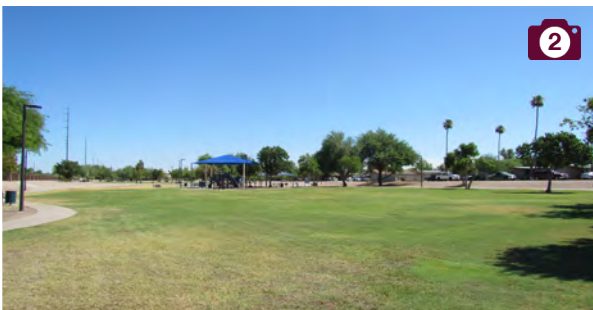
South Turf Area

The south turf is in average condition. There are some hard compaction areas throughout turf areas. The storm drain outlet areas in the south area near Erie Street show worn turf and the area is very compacted. An aeration and soil agronomy test to evaluate soil condition is recommended.

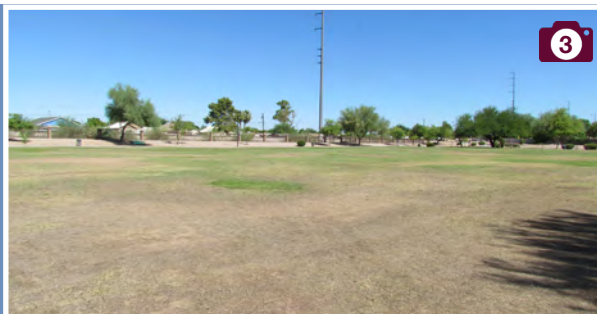
North Turf Area

The north turf area is in poor condition. There are a lot of worn areas throughout and the area is very compacted. An aeration and soil agronomy test to evaluate soil condition is recommended. The worn condition of slopes is due to lack of irrigation maintenance not activity.

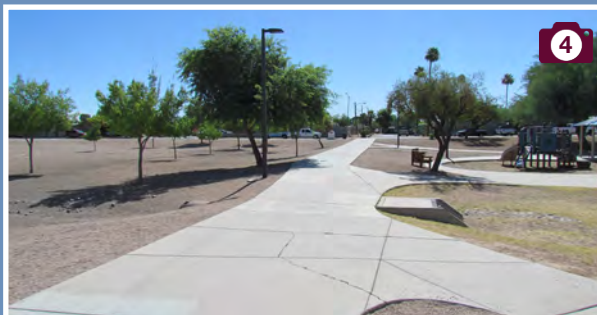
Sidewalk

The concrete sidewalk is in average condition. There are cracked panels throughout the park and several areas have been previously replaced.

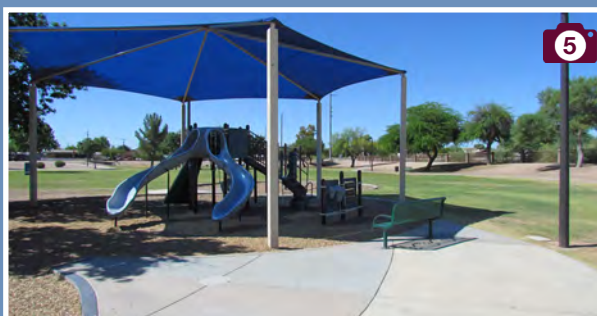
Playground

The playground area in good shape and the header curbs and sidewalk areas are good condition. The play equipment is in good condition.

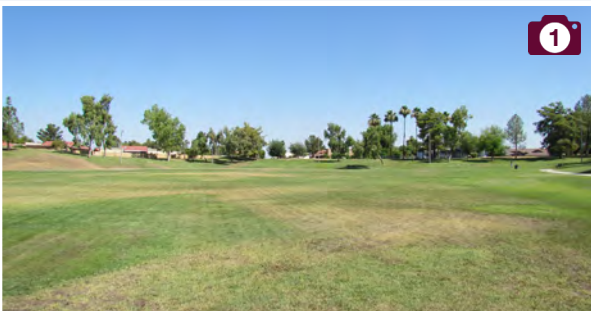
Turf in Basin

The turf in the west basin is in average condition and there are some wear areas on the floor and sideslopes. The condition of slopes is due to lack of irrigation maintenance not activity. The turf areas appear pretty compacted throughout. An aeration and soil agronomy test to evaluate soil condition is recommended.

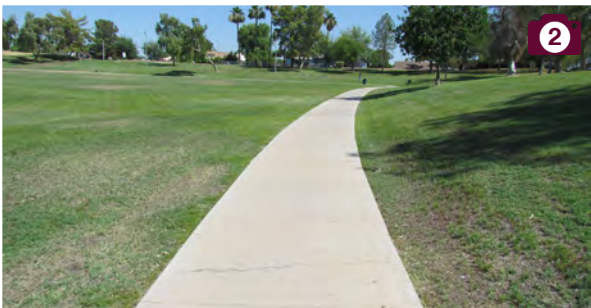
Sidewalk

The concrete sidewalk is in average condition. There are a number of panels with minor cracking, which should be monitored but there does not appear to be any vertical separation.

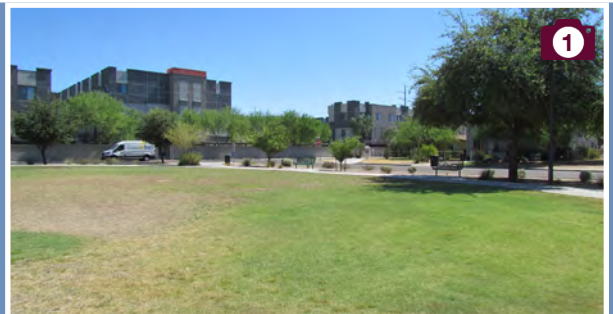
Turf Area

The north turf area is in poor condition with a lot of worn areas and very compacted throughout. An aeration and soil agronomy test to evaluate soil condition is recommended.

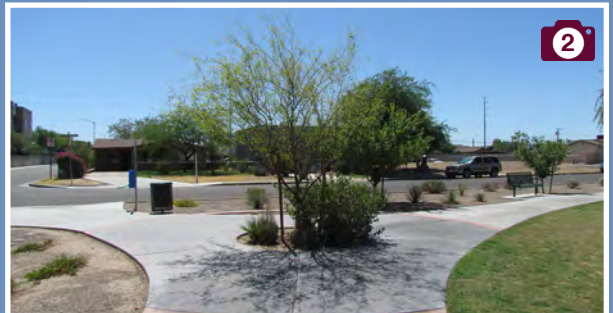
Sidewalk

The concrete sidewalk and park pathways are in new condition.

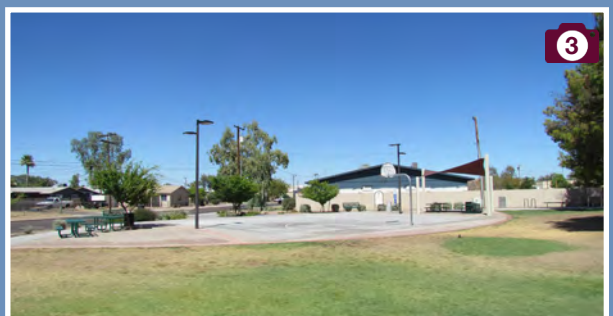
Basketball Court

The concrete post-tension court is in good condition and the lighting is LED fixtures.

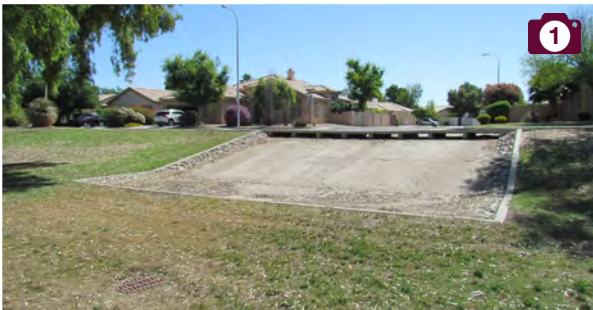
Overall Drainage

The north turf area serves as a large retention basin for the surrounding subdivision. The offsite drainage is conveyed to the north retention basin through an existing 32-foot-wide scupper with eight (four-foot-wide openings from N. Madrid Lane. There are no signs of erosion at the drainage conveyance transition point from scupper pan to turf. The basin has existing drywells.

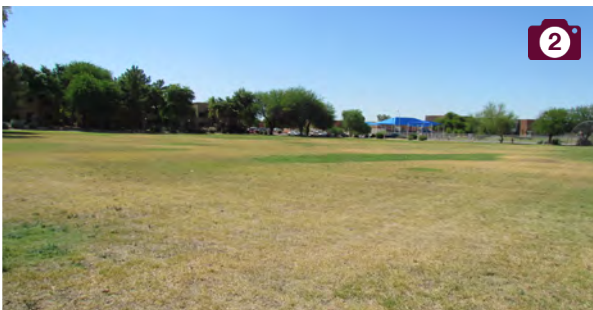
Turf

The southern turf area is in average condition. The middle turf area near the playground has non-growing areas under the larger tree shade canopies. The northern turf area has some dead zones. The coverage and condition of the sprinkler irrigation should be verified. An aeration and soil agronomy test to evaluate soil condition is recommended.

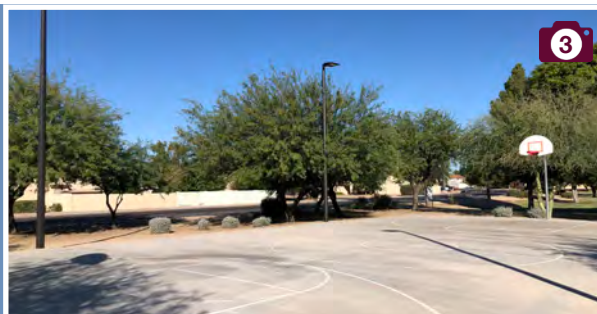
Site Lighting

The playground, basketball, and sand volleyball courts all have new LED light fixtures and poles.

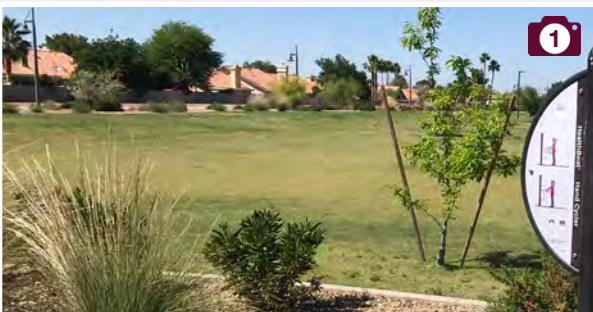
Turf Area

The turf is in good condition with some wear areas, but showing strong growth. An aeration and soil agronomy to evaluate soil condition and recommendations for amendments.

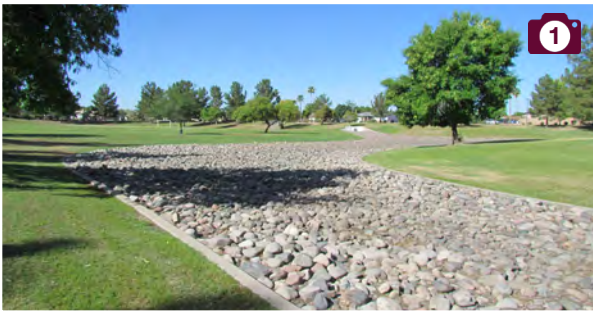
Overall Drainage

The park's lower turf area on the west side of the park site provides drainage storage for offsite storm water from Mesquite Street and Evergreen Street. The offsite runoff is conveyed by storm drain entering at the north east area of the lower basin. A large riprap-lined area connects the three storm drain pipe outlets. The riprap is held in place with a concrete-header curb.

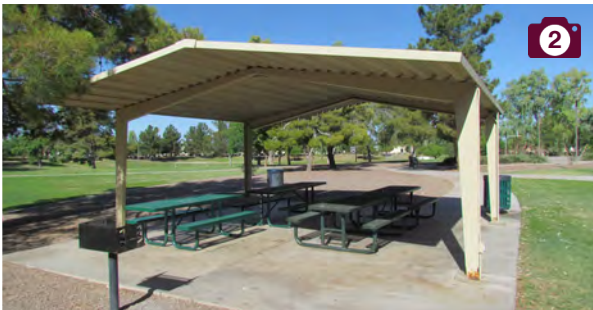
Ramadas

The park has older ramada structures funded through the Land and Water Conservation Fund, which is a federal program providing Cities with grants to promote outdoor recreation. Some rusting at the ramada column foundations is present.

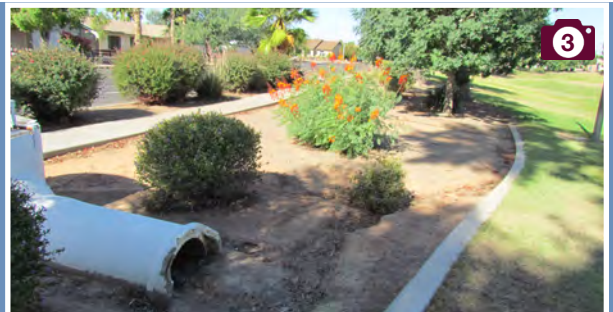
Sidewalk

The concrete sidewalk is in average condition. A few panels show some cracking.

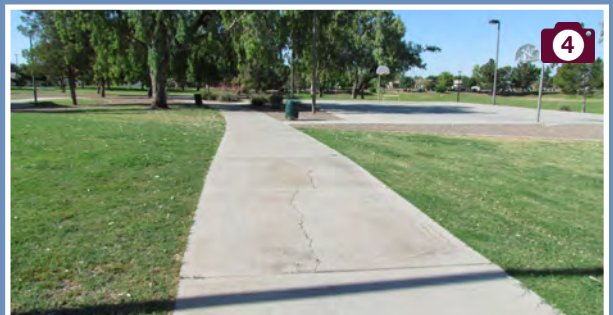
Basketball Court

The concrete post-tension court is in good condition. The existing court lighting is high-pressure sodium and a LED fixture replacement is recommended.

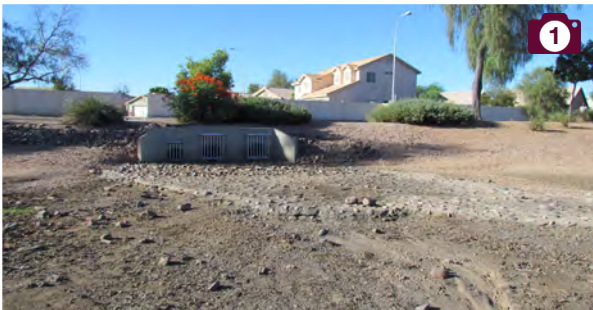
Overall Drainage

The park provides storage for surrounding offsite drainage runoff and has multiple access points with storm drain outlet points and scuppers. The east basin has three storm drain outlets within a headwall and outlets to a decomposed granite area that has become fairly silted. There is a grouted riprap channel, which connects to the turf area, but drainage fans out in the decomposed granite area.

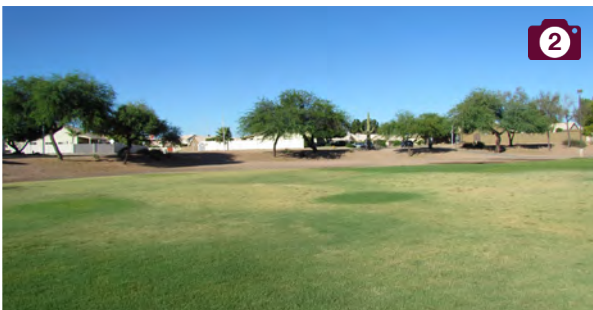
Turf

The turf is in good condition but there are a few worn areas. The ground appears very compacted throughout. An aeration and soil agronomy test to evaluate soil condition is recommended. The worn condition of slopes is due to lack of irrigation maintenance, not activity.

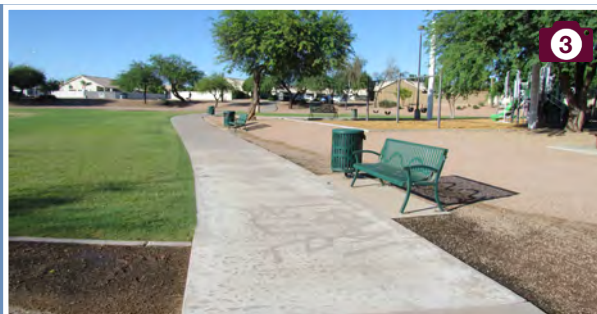
Sidewalk

The concrete sidewalk is in good condition but there are a few panels with cracking.

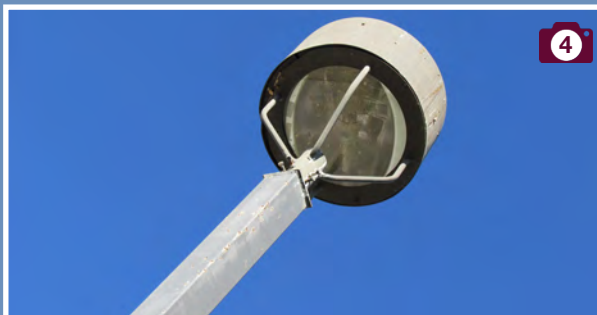
Site Lighting

The lighting around the path in the park is high-pressure sodium. LED fixture replacement is recommended.

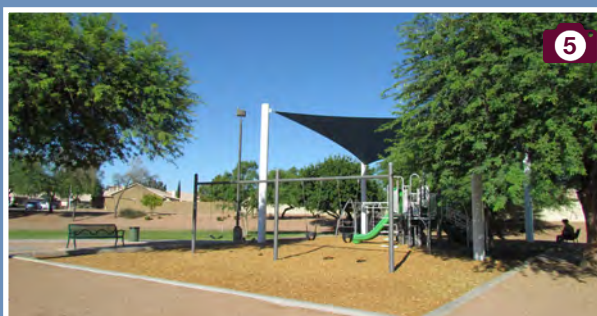
Playground

The playground area is in good shape. The header curbs, sidewalk areas, and play equipment are in good condition.

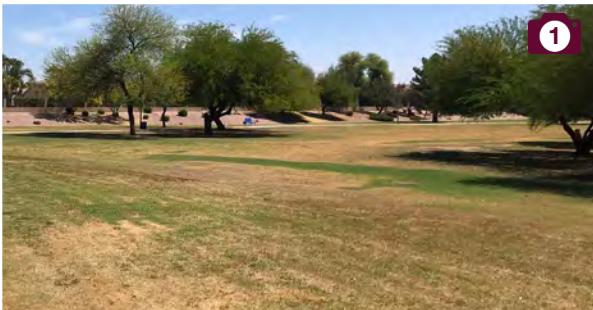
Turf Areas

The turf is in below-average condition with worn areas and compaction throughout. An aeration and soil agronomy test to evaluate soil condition and recommendations for amendments is suggested.

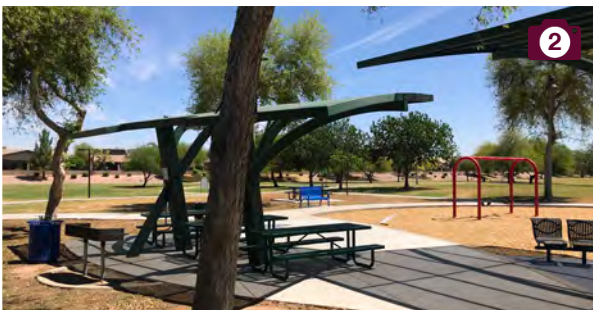
Sidewalk and Concrete Plaza Areas

The concrete sidewalk is in average condition.

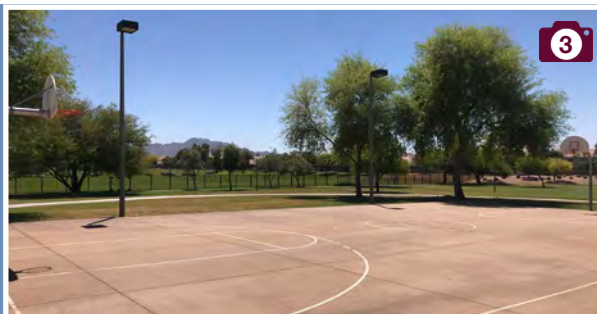
Pickleball Court and Play Court

Concrete pickleball and play court are in good condition and court lighting is high-pressure sodium. LED fixture replacement for court lighting is recommended.

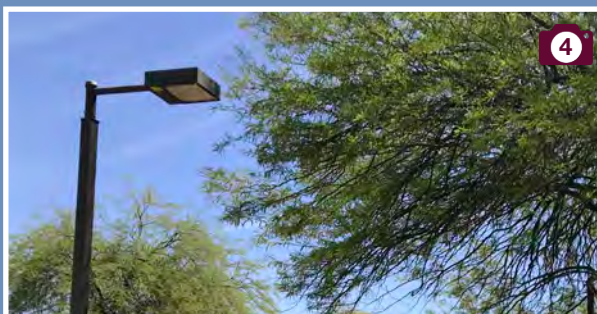
Site Lighting

The site lighting is high-pressure sodium fixtures with a combination of shoebox and decorative fixtures throughout the park. The fixtures and poles are in good condition. The replacement of existing fixtures with LED can wait until the current fixtures reach their lifecycle.

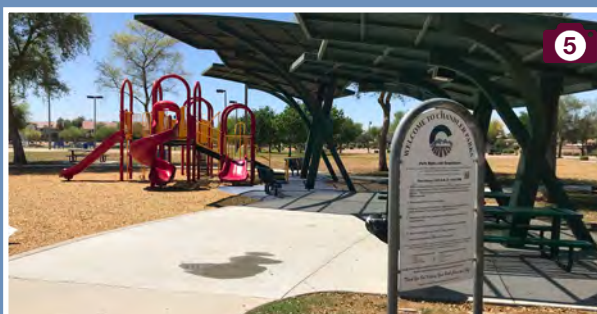
Playground

The playground area is in good shape, while the header curbs and sidewalk areas are in new condition. The play equipment is in new condition.

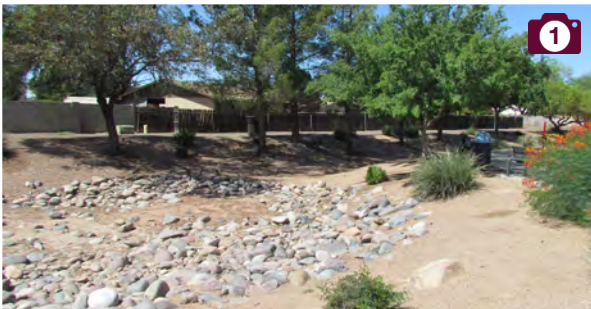
Overall Drainage

The park provides retention for Erie Street along the perimeter of the park. Offsite drainage is conveyed to the perimeter of the park through three concrete scupper areas. The perimeter park basin utilizes large riprap rock in the lower basin areas.

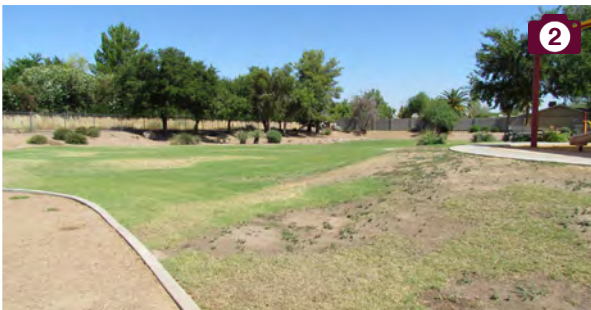
Turf Area

The turf area is in poor condition. The slopes are difficult for turf to establish on and around the playground area. An aeration and soil agronomy test to evaluate soil condition is recommended.

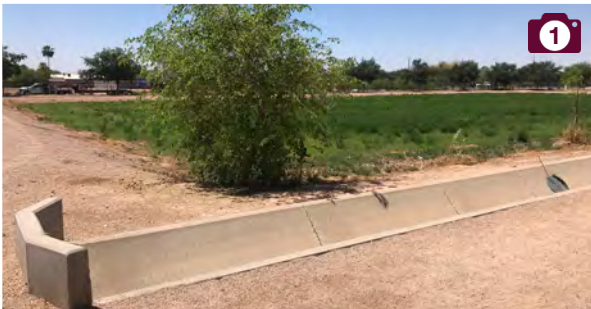
Overall Drainage

This linear park provides a concrete multi-use path and DG pathway connection to the Paseo Trail System along the consolidated canal. The park has four large overgrown agricultural field areas, which are depressed and utilizes flood irrigation fed from the existing concrete lined channel. The park does not receive and offsite storm water runoff from the adjacent street frontage. The site self retains onsite drainage to the surrounding turf areas.
