**Economic Development – Council Memo ED12-014**

**SUBJECT:** Adoption of Resolution No. 4552, finding and declaring a 16-acre parcel of real property at the southeast corner of the Price Freeway and Chandler Boulevard to be a slum area for which redevelopment is necessary in the interest of the public health, safety or welfare of the residents of the City of Chandler.

## SITE ANALYSIS FOR DETERMINATION OF REDEVELOPMENT DECLARATION

2929 West Chandler Boulevard  
Chandler, Arizona

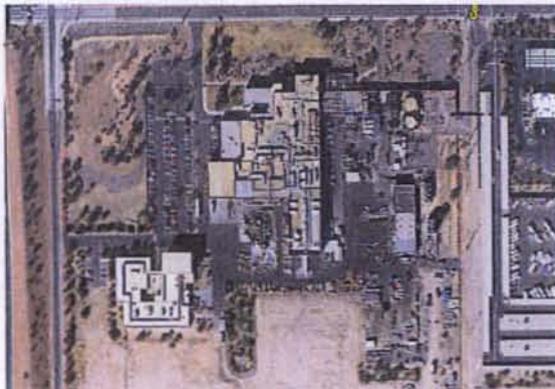
Exhibit A. Gould Electronics Facility in operation- 2005

The Gould facility consisted of a 92,650 square foot manufacturing facility, an 11,000 square foot warehouse, electric substation, wastewater treatment plant and surface storage basins, tank farm, storage areas, solar panel array field, and paved parking and drive areas. The facility remained in operation until 2006 when Gould ceased operations. The Gould portion of the facility was demolished and sold. The Nikko operation still exists at a location immediately southwest of the subject property.

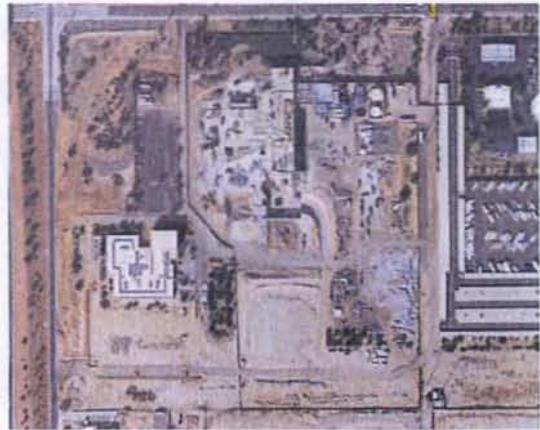
Exhibit B. Demolition of Gould Facility-2006

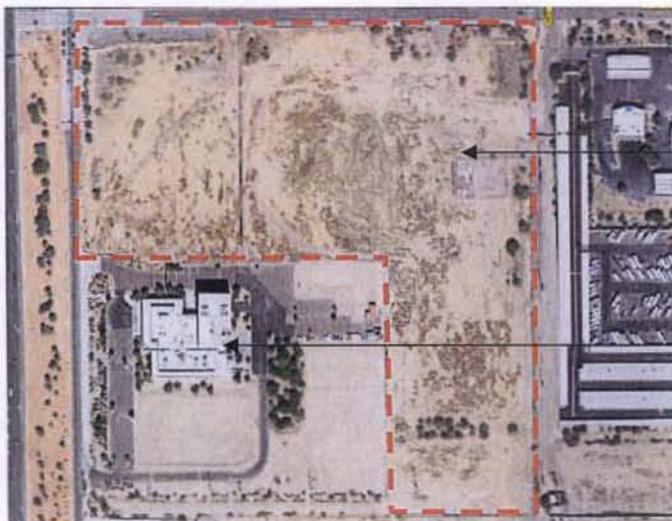
Subject property  
(formerly Gould Electronics)

Nikko Materials manufacturing facility

Exhibit C. Subject Property, 2009

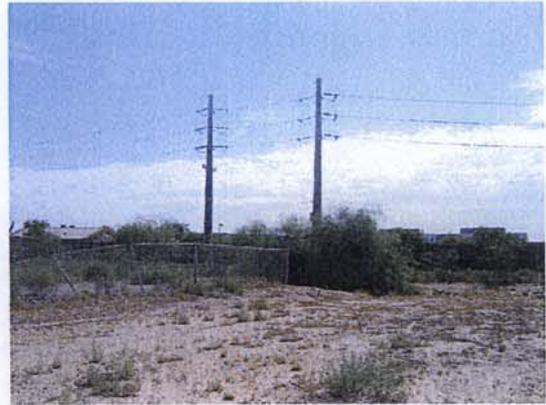
Exhibit E. 69KV Power Lines

The eastern boundary of the site, and especially the northeast, possesses numerous utilities. 69KV and 12KV electrical poles bound the eastern property line as do gas line facilities and easements. The northeast corner of the property contains a number of utility boxes for power, gas, and water.

To facilitate the development of Coronado Street south of Chandler Boulevard, the existing 69 kilovolt and 12 kilovolt power lines will need to be relocated and placed below grade, respectively. As part of this undertaking the 12 KV lines currently accompanying the power poles will be placed underground and the 69 KV lines relocated, presumably near their current location.

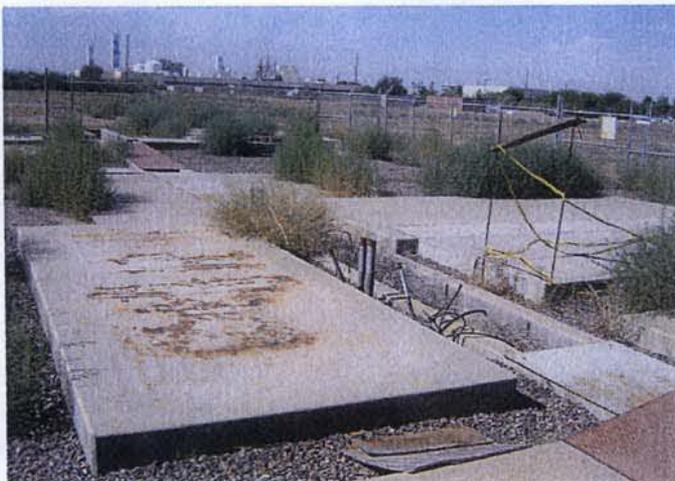
The former SRP electrical substation is a visible, above ground remnant on the property. As seen in exhibit F, this area contains numerous concrete slabs and vaults, steel plates, wiring, plastic piping, and other materials. The exposed vaults will be discussed later in this report.

Exhibit F. Former SRP electrical substation

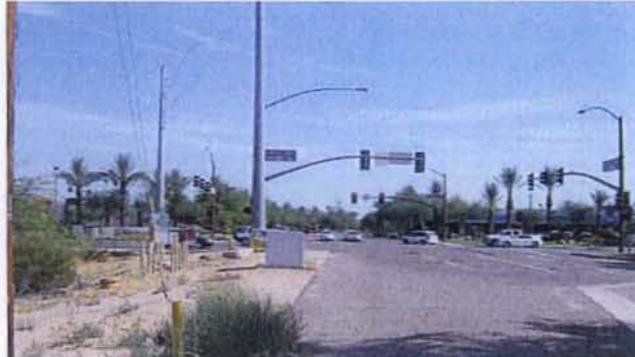
Exhibit G. Coronado Street & Chandler Boulevard intersection facing north

Exhibit G shows the current condition of Coronado Street terminating at Chandler Boulevard. Surrounding street patterns and general transportation planning practice would suggest that Coronado Street would continue directly south and the burden

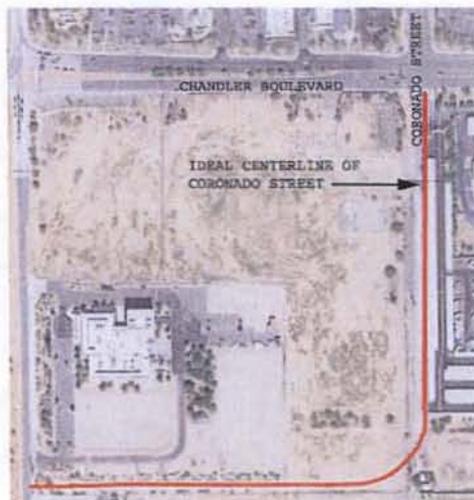
Exhibit H. Road alignment under ideal conditions

future Coronado Street alignment. Because of this existing condition, the owner of the subject property has no alternative but to place a publicly dedicated street entirely on the subject property. Without this significant burden and loss of valuable land, the property would not be afforded adequate access or circulation. Exhibits H & I illustrate this condition.

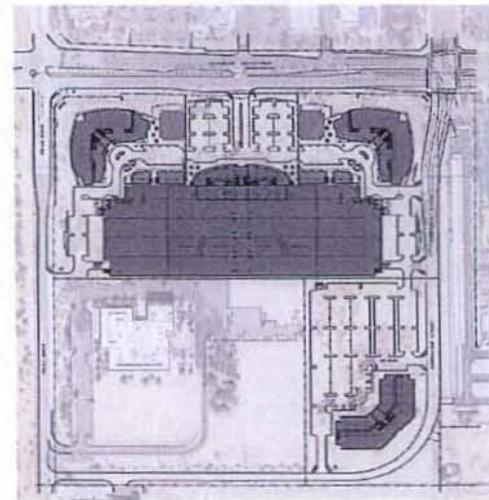
Exhibit I. Actual planned road

of right-of-way dedication would be split between the two adjoining property owners evenly. However, in 1997 San Tan Storage was permitted to construct a storage facility near the western property boundary without regard, dedication, or improvement, for the

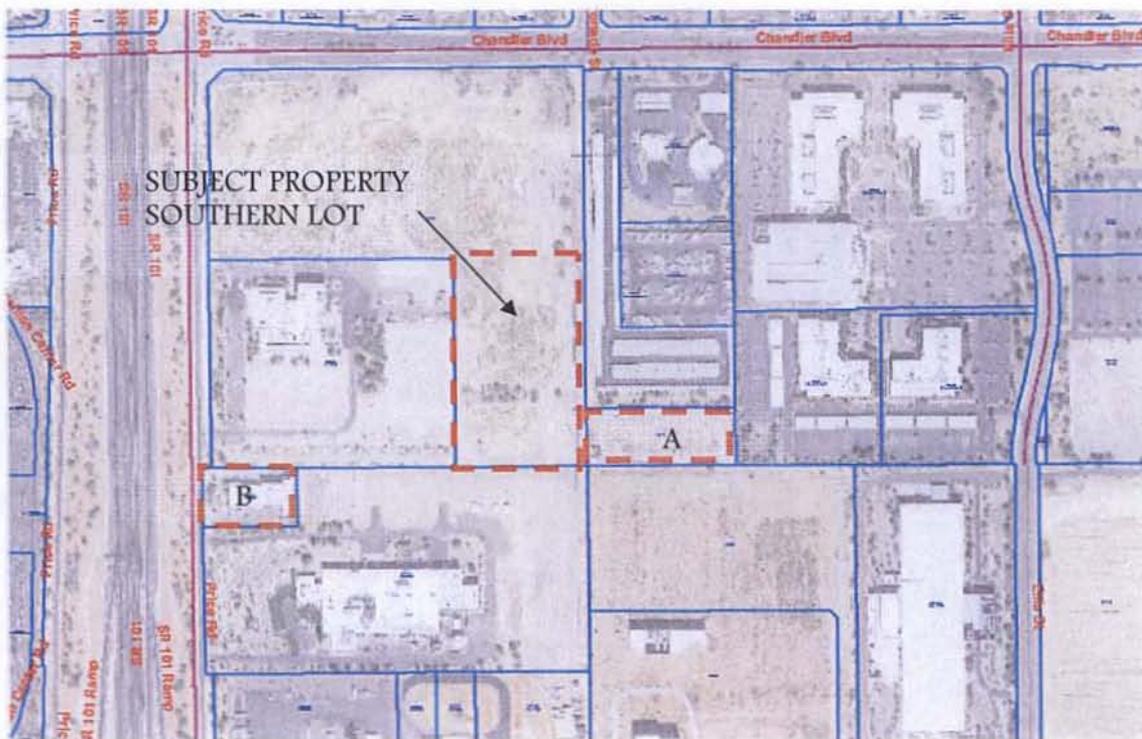
As depicted in exhibit J, the current lot and parcel layout of the subject property as well as surrounding parcels present a dilemma in regards to property access. In the current state, the southeastern portion of the subject property is significantly hindered, as the closest public street is nearly ¼ of a mile away at Price Road or Chandler Boulevard, respectively. Furthermore, the parcel directly east of the subject property (noted as parcel “A” in Exhibit J) is land locked with absolutely no public street access, making development all but impossible. It should also be noted that the City of Chandler Fire Support Service Facility (Exhibit J, parcel B) relies entirely on access from the Price Freeway frontage Road. While all of these properties stand to eventually benefit from the proposed development of Coronado Street, they are currently hindered by access issues as a result of faulty lot layout.

Exhibit J. Property access constraints

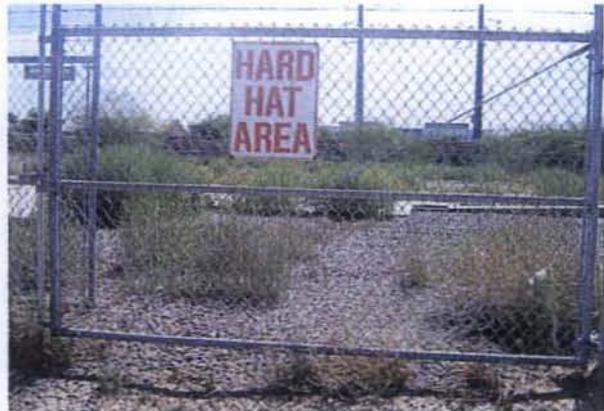
The Gould manufacturing facility included an SRP electrical substation in the northeastern part of the site. While most of the electrical equipment was removed from this area, concrete slabs, foundations, conduit, concrete chases, and steel plates remain intact. Most significantly, open concrete lined vaults exist in this area. The most noticeable uncovered vault is approximately 15 feet long, 5 feet wide, and reaches a depth of approximately 10 feet below ground level. The exterior perimeter of the 24 acre property is fenced with a locked gate on the north side of the site. There is also an additional fence around the former substation area but the fence is in ill repair and deteriorated to a point where it is ineffective. We recognize this area as an unsafe condition (with or without proper fencing) and a threat to public safety.

Exhibit K. Gate at Substation

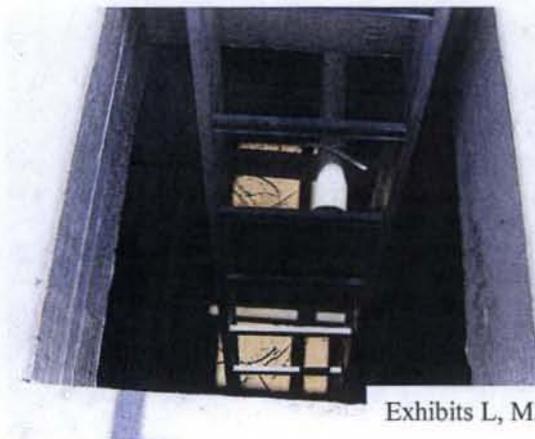
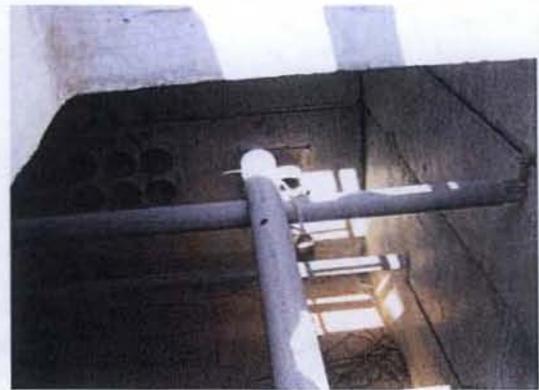
Exhibits L, M. Obsolete utility vaults from substation remain open

- The subject property contains a defunct electrical substation with open vaults, the presence of these vaults pose a direct threat to public safety. The defunct electrical substation negatively impacts the development of approximately 5,500 square feet of the subject property

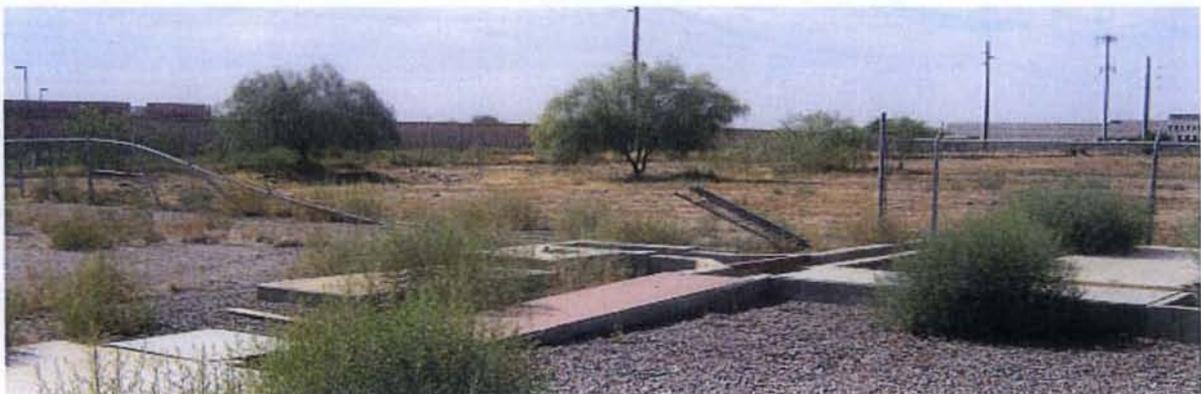
Exhibit N. Dilapidated fence surrounding former substation

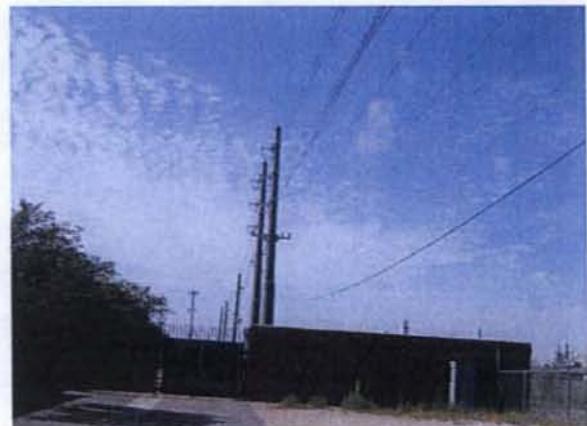
Exhibit O. Utility lines along east border of site

- The subject property contains approximately 2,368 feet of 12 KV and 69 KV power lines with 14 supporting 12 KV and 69 KV power poles. Many of these poles must be relocated for redevelopment. These power lines and power poles negatively impact the development of approximately 141,750 square feet of the subject property.
